# COTTAGES AT HASTINGS GREEN

7021-7071 SE Clinton St, Portland, OR 97206

## EXTERIOR ENVELOPE ASSESSMENT

2019-CHG-001

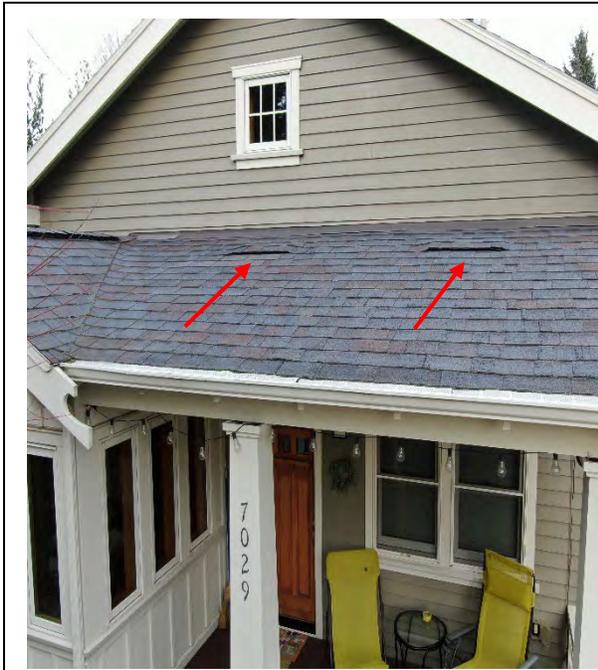
1.5 Typical under shingle venting at front porch area

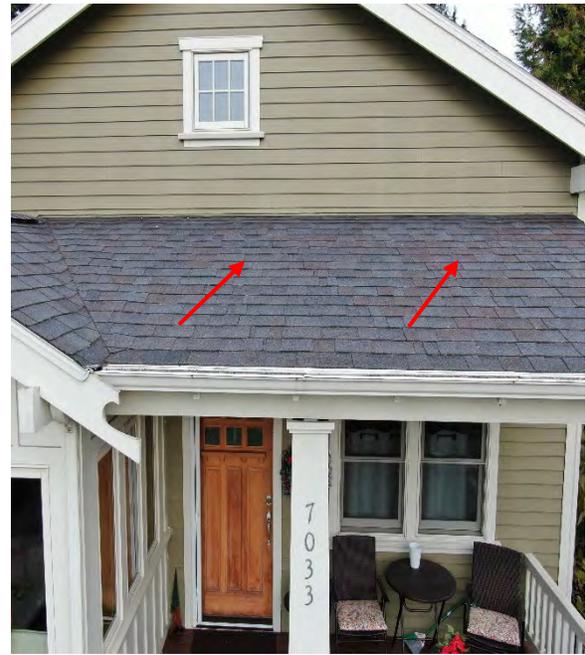
1.6 Under shingle venting is missing at front porch area of #7033.

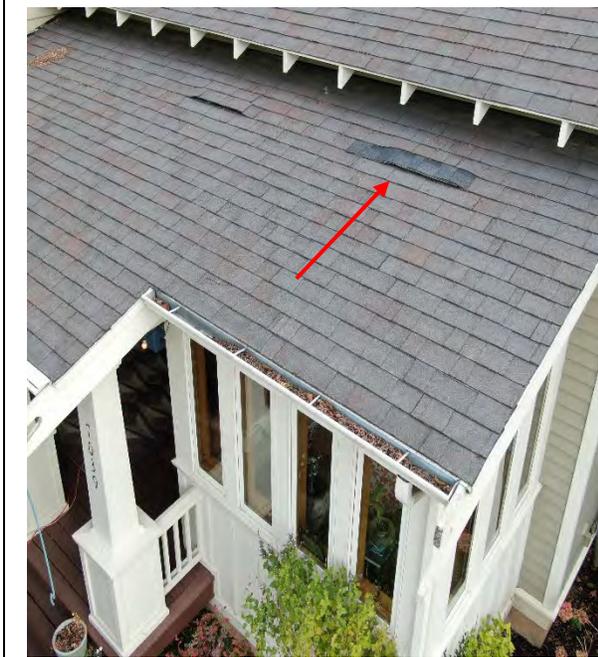
1.7 Shingle was repaired over under shingle venting at #7039. There are concerns of a previous leak at this area.

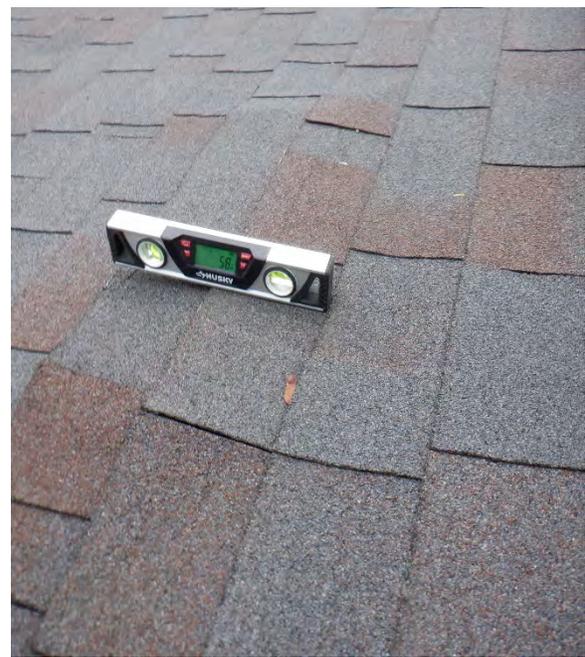
1.8 Roof pitch at under shingle venting areas of most units is low, which could possibly allow water to saturate through the shingles.

- 1.8: Roof pitch at under shingle venting areas at most units is low, which could possibly allow water to saturate through shingles.
- 1.10: Roof pitch is 3/12 and self-adhered membrane was installed at the underlayment.

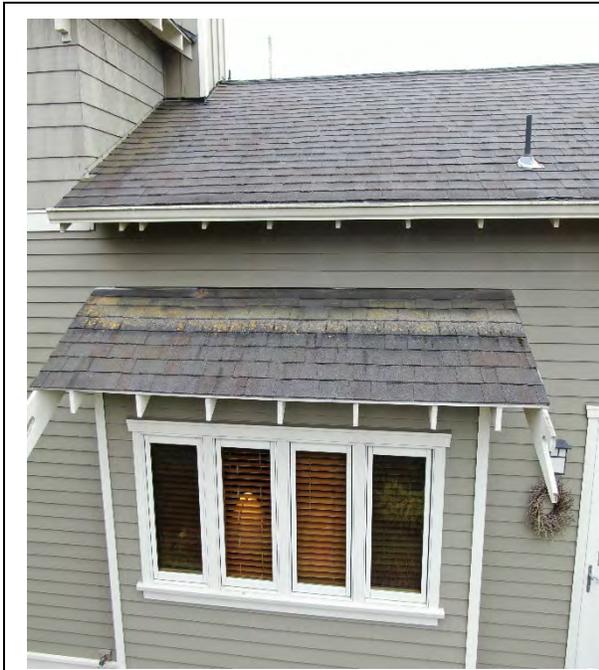
1.9 Some units have omitted venting at roof area over living space (#7022, 7025, 7038, 7039, 7046, 7047, 7067).

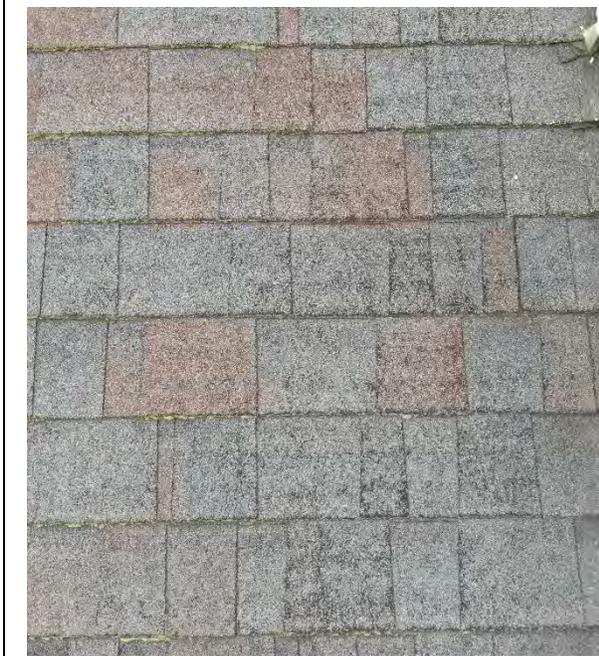
1.11A Shingles have more than typical granule loss at #7029 and 7033.

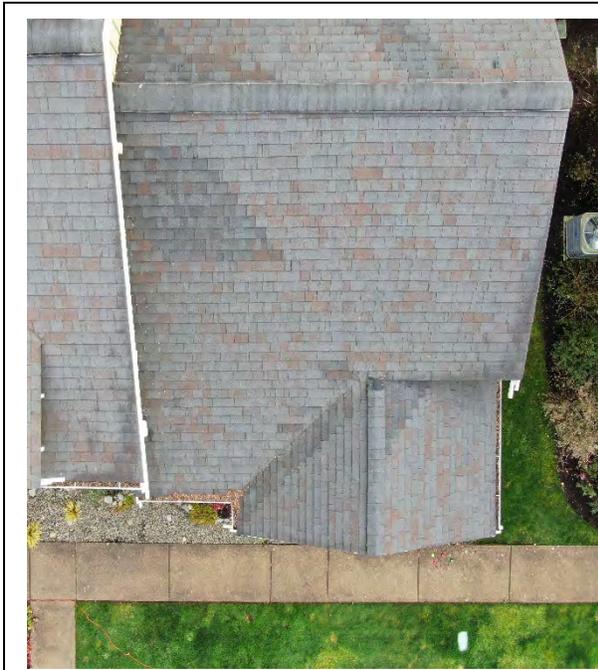
1.12A It appears that repairs have been made to some shingles at #7026, 7043, 7046, and 7051.

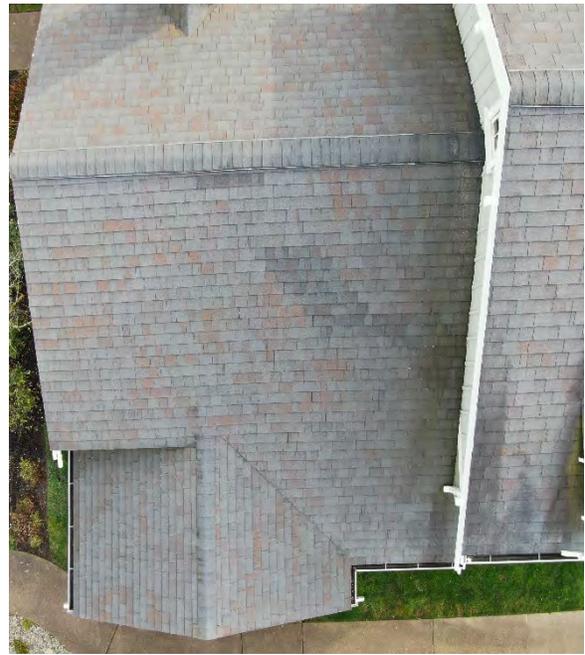
1.12B Another example of previously repaired shingles.

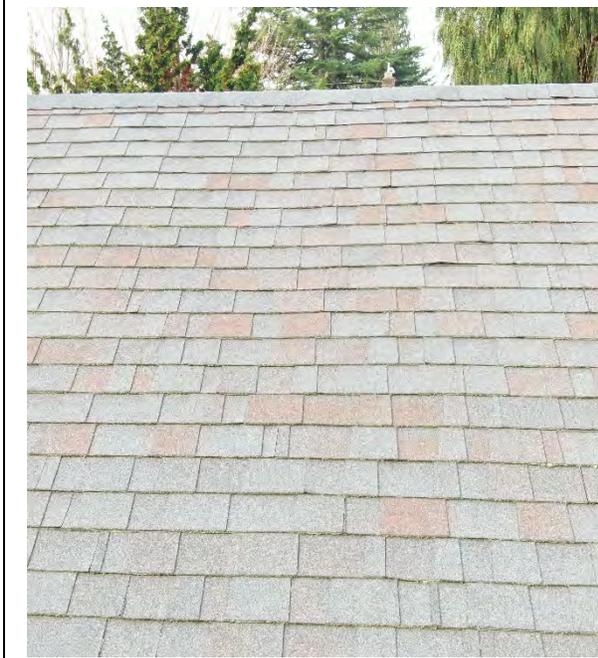
1.13A Shingles are butted tight to each other and it appears that fasteners are not nailed flush to shingle at #7071.

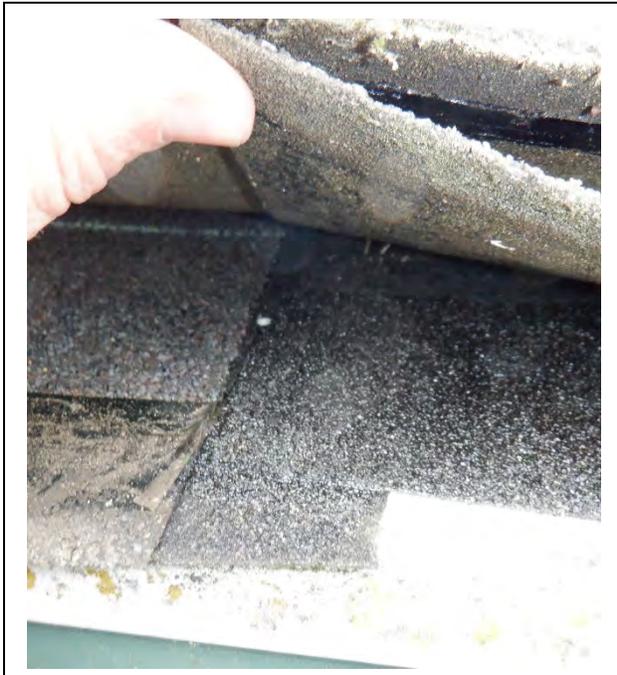
1.14 Starter strip appears to be improperly secured with short staples at almost all units. However, there is no apparent blow off due to this condition.

- 1.14: Starter strip appears to be improperly secured with short staples at almost all units. However, there is no apparent blow off due to this condition.

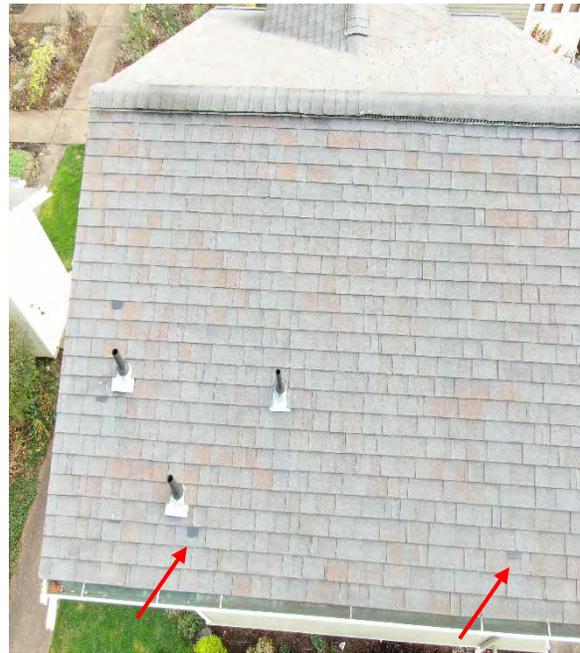
1.15 Metal installed under shingle where base of pump jacks was installed over roof at #7071. The ends of metal are exposed, and it is unclear if metal is properly secured.

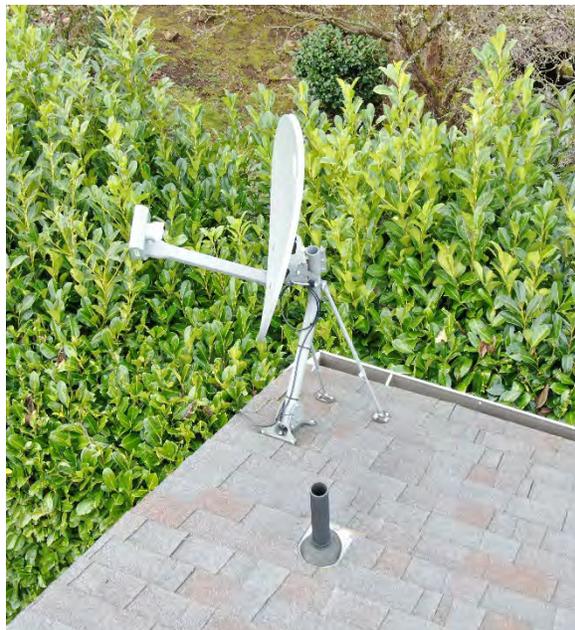
1.16 Satellite dish was installed through shingles at #7026, rather than the recommended method of brackets at barge board, rafter tails, or roof mounts.

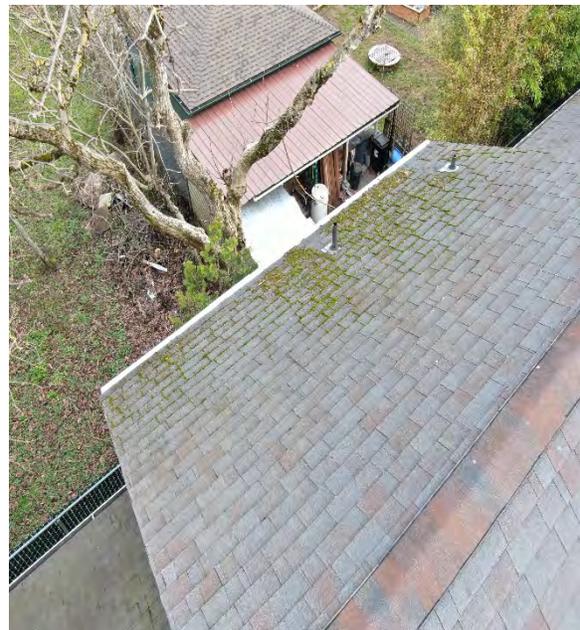
1.17A Moss is growing on shingles at #7042.

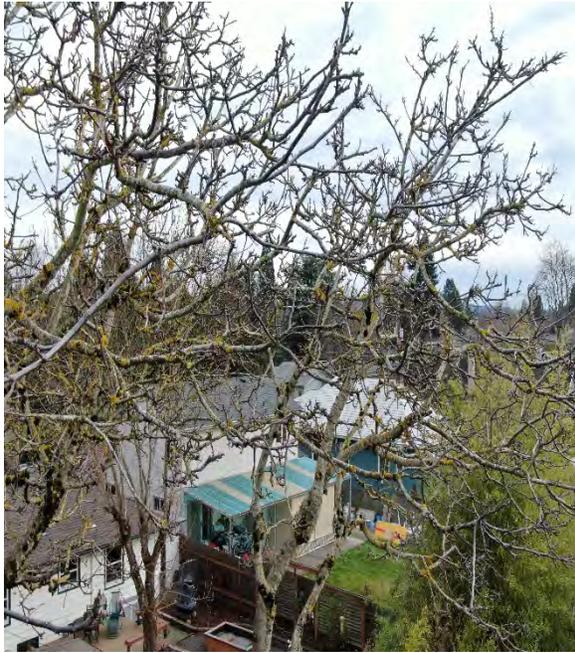
1.17B Trees are growing over roof at #7042, which is the main cause for moss growth.

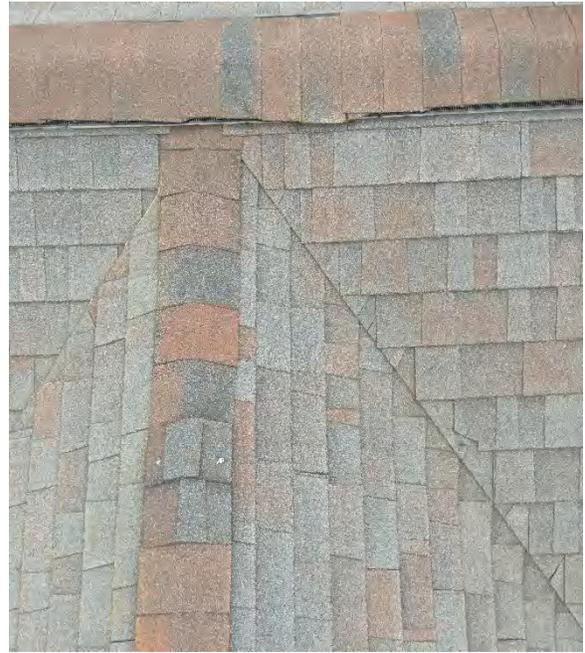
One more major area of concern are the ridges. There are multiple issues, including improper material used, different colored material used, and numerous previous repairs. Due to the number of repairs that have been performed, it may indicate a more serious issue. Further review is needed.

1.18A Standard laminated shingles were used at ridge cap instead of proper material at #7022, 7034, and 7059.

**Roofs:** Hire qualified contractor to address minor repair/maintenance items noted in Observations section. More extensive issues, such as ridges, can be addressed when the roofs are replaced in 3-5 years. Until the roofs are replaced, they should be observed and maintained on a regular schedule to ensure full useful life is achieved.

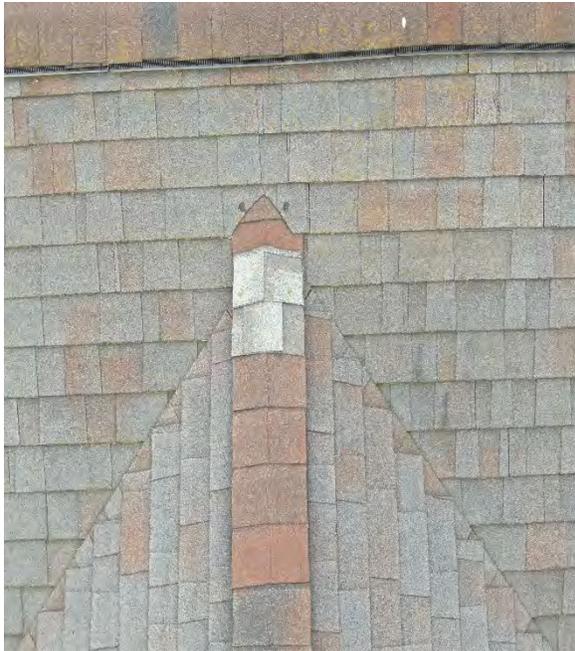
1.18B Another example of improper material used for ridge cap.

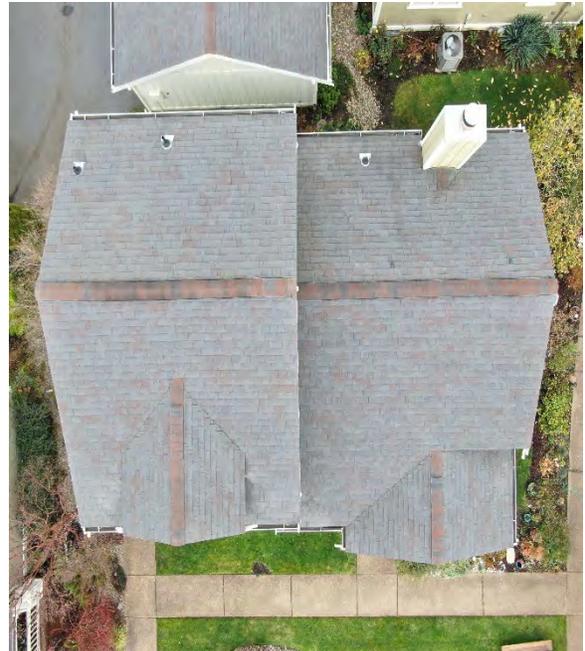
1.19A Different colored ridge cap was used at #7026 and 7058.

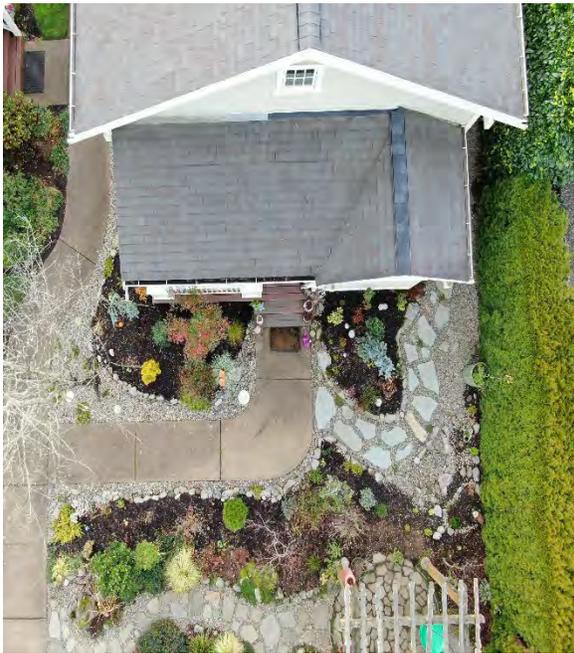
1.20A Some repairs have been made to the ridge cap at #7021, 7022, 7026, 7046, 7055, 7058, 7059, and 7071.

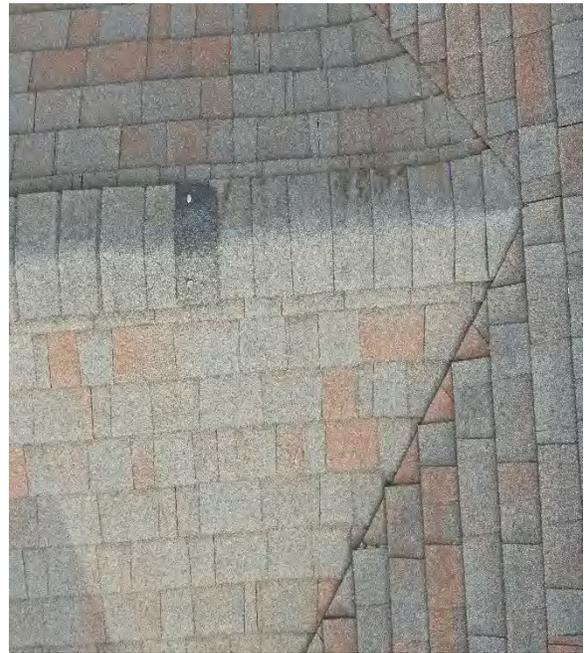
1.20B Another example of previously repaired ridge cap.

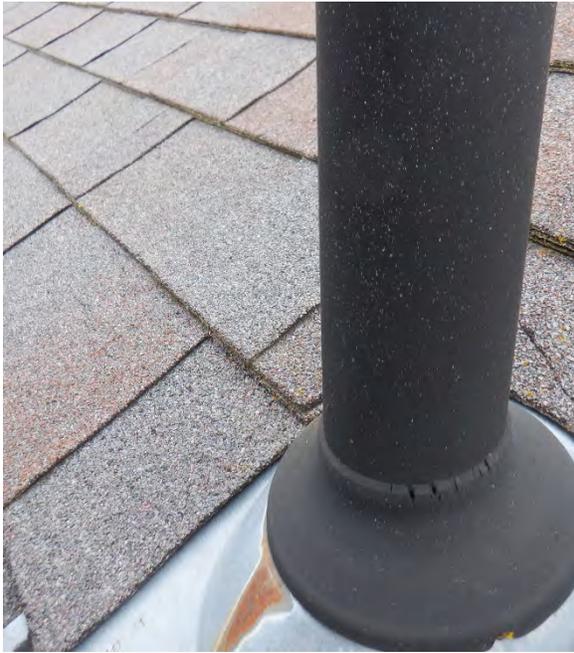
1.21 Gasket on no-caulk pipe flashing is beginning to crack.

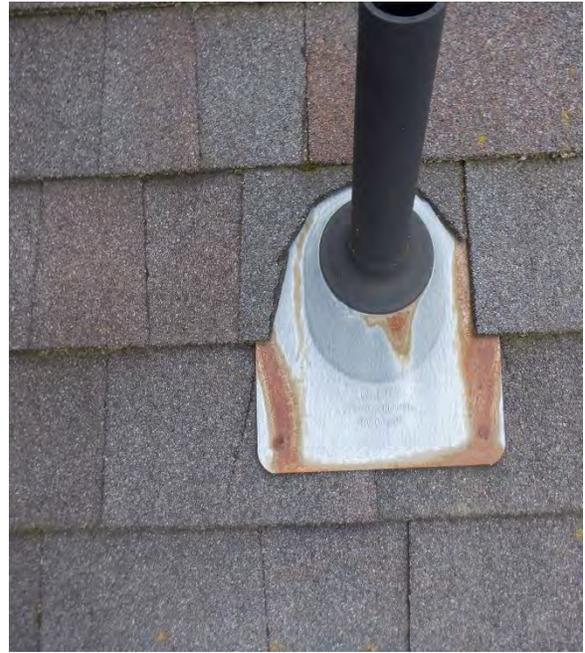
1.22 Base of pipe flashing is corroding and there is no sealant on exposed fasteners.

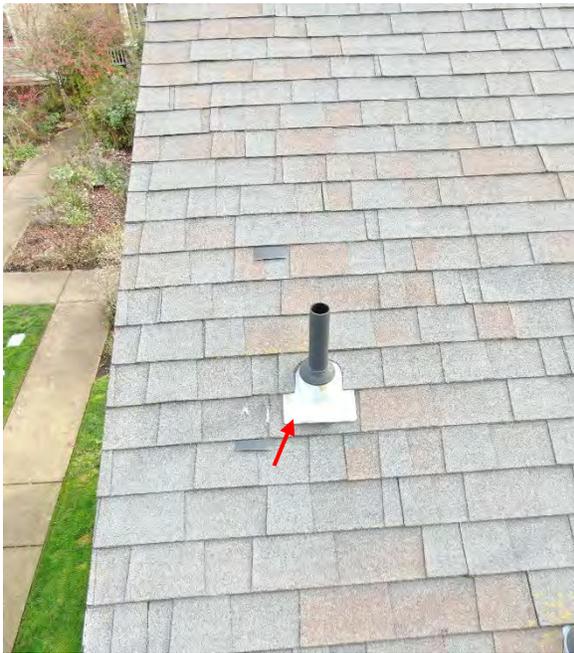
1.23 Base of pipe flashing is not properly secured at #7071.

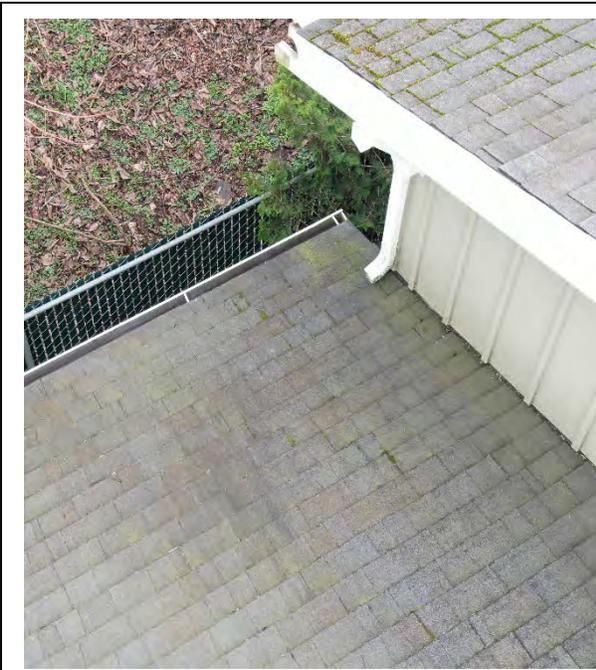
1.25 Downspout drains onto lower roof at #7026, 7042, 7043, 7050, 7058, 7059, and 7071. It should be extended to lower gutters to prevent excess water on the roof.

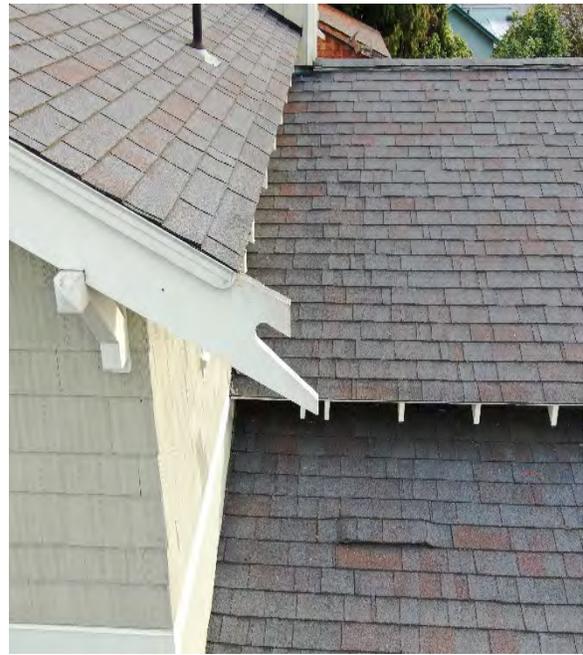
1.26A Extended barge boards throughout property have no top protection, which could lead to wood decay.

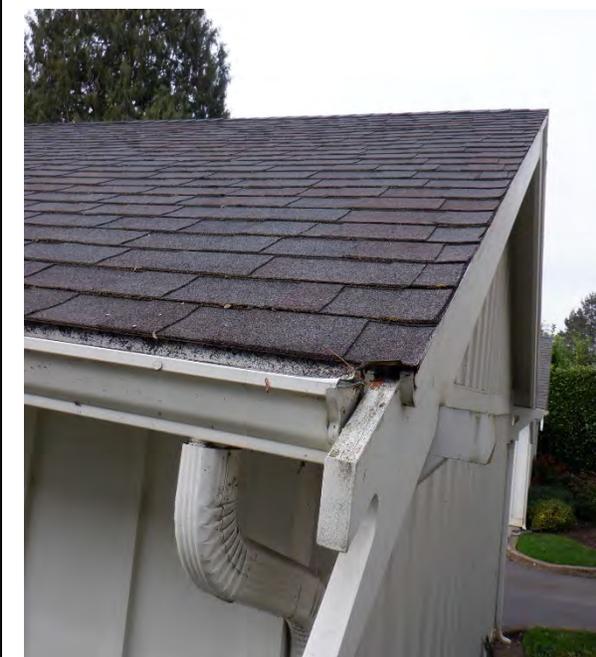
1.26B Closer view of extended barge board with no top protection.

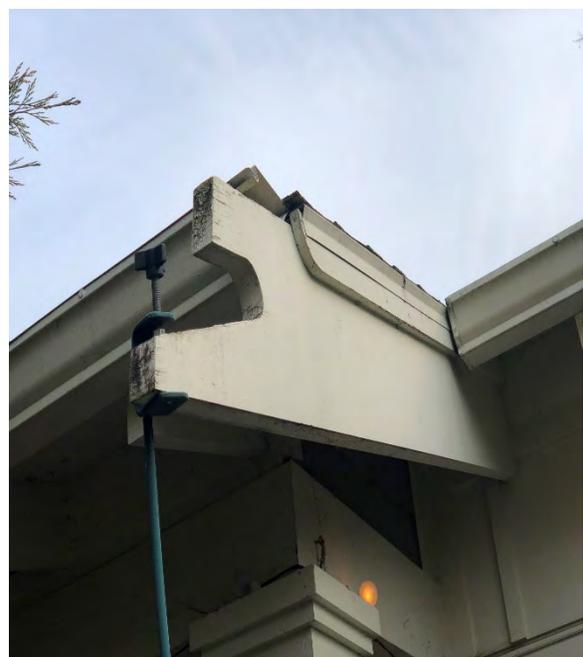
1.27A Deterioration and organic growth present at extended barge boards.

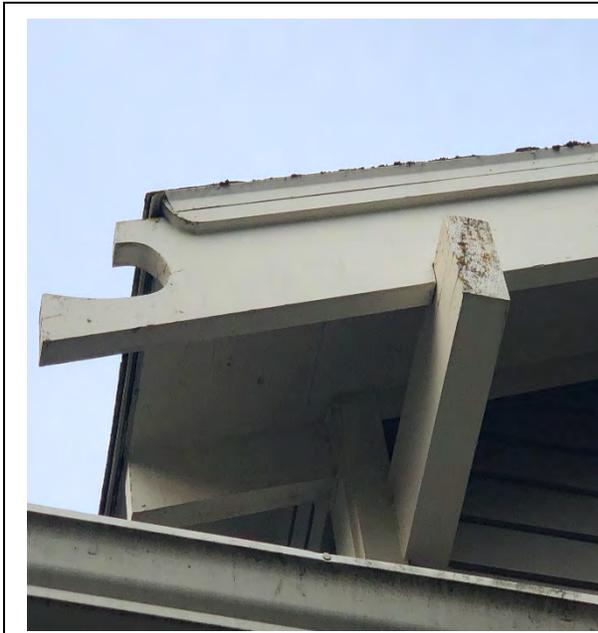
1.27B Another example of deteriorated extended barge board.

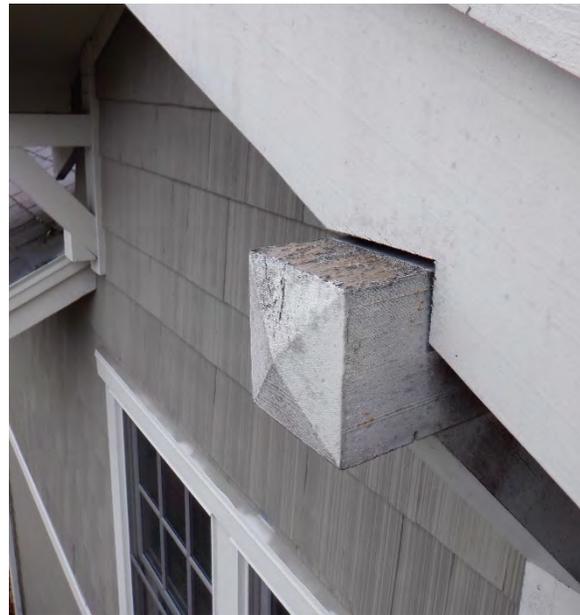
1.28 Metal protection omitted at top of barge board supports at all units.

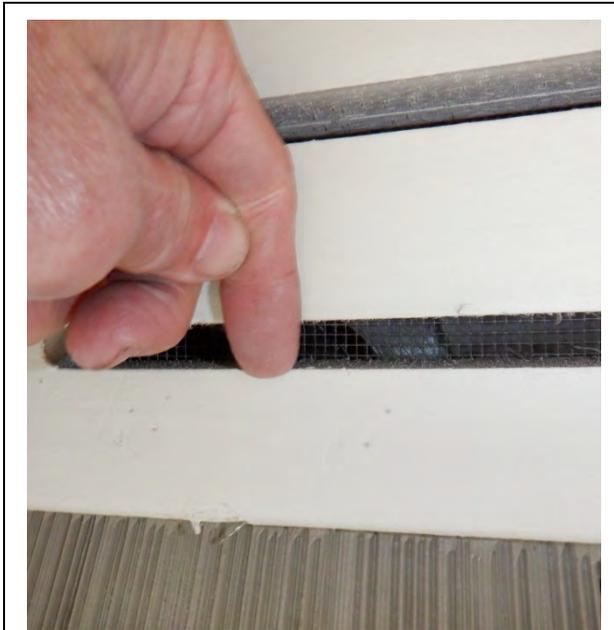
**Attics:** Although no attic observations were performed, what appears to be ducting run to the small eave vent was observed from the exterior. Ducting may not be tight lined to the exterior, which is an issue that should be repaired. Further review of attics is needed to verify.

2.1 It appears that ducting may not be tight lined to exterior, as ducting is run to small eave vent. Further review of attics is needed to verify extent of issue.

**Attics:** Further review should be performed to determine ducting and other component conditions in the attics. A preliminary attic review can be performed on a few units before extensive observations are performed to help determine scope of services needed.

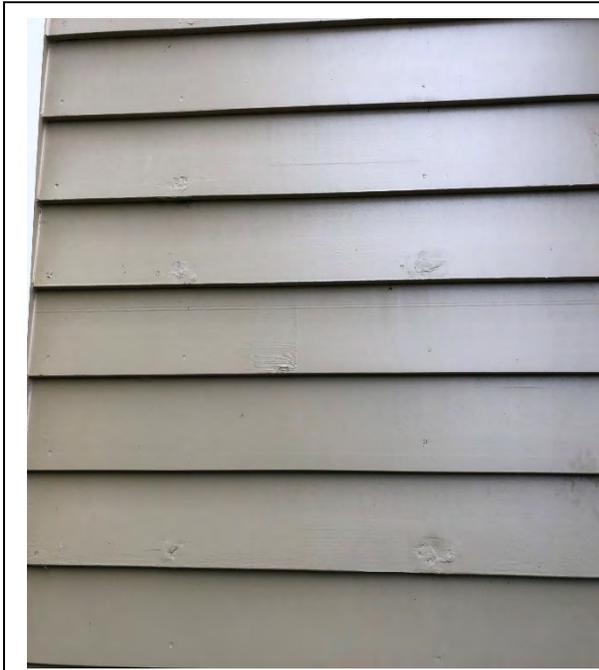
3.1A Siding and/or paint is damaged at #7022, 7025, 7030, 7038, 7042, 7046, 7051, 7054, 7058, 7063, 7067, and 7071.

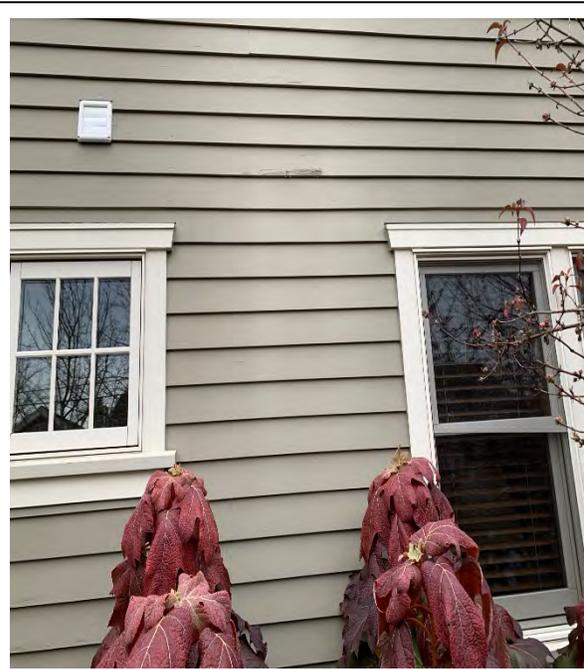
3.1B Another example of damaged siding and/or paint.

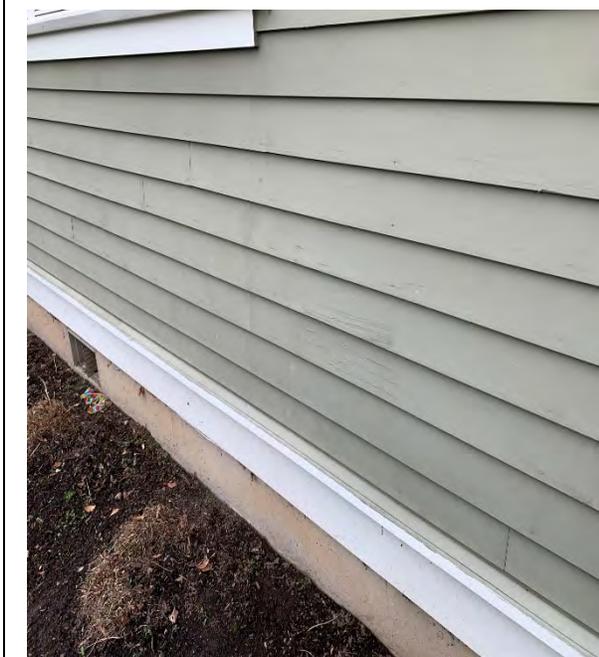
3.1C Another example of damaged siding and/or paint.

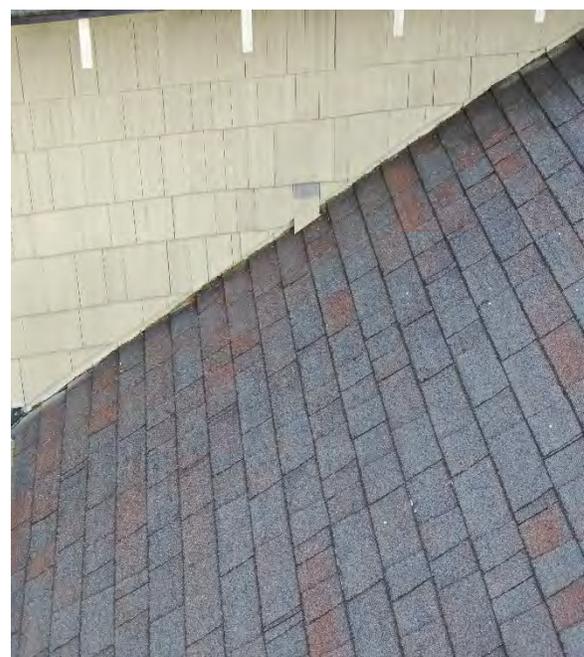
3.2 Shake siding at side wall is not properly secured (#7039).

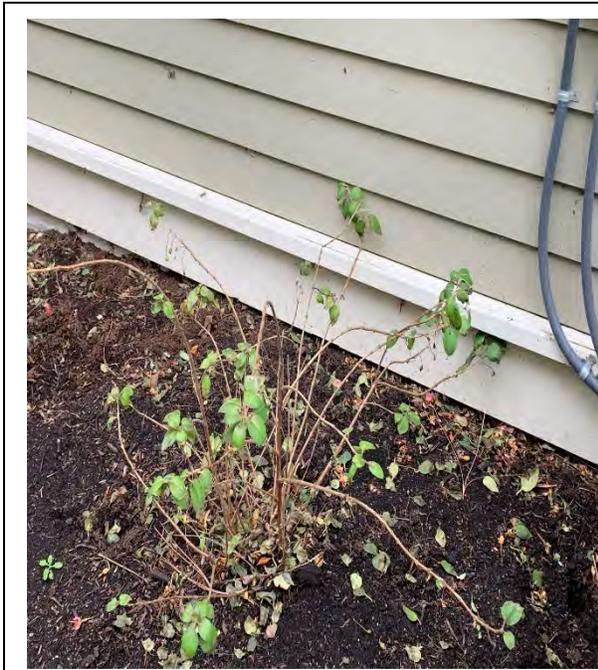
3.3A Siding is too close to grade at #7047 and garages. There should be a minimum 6" clearance.

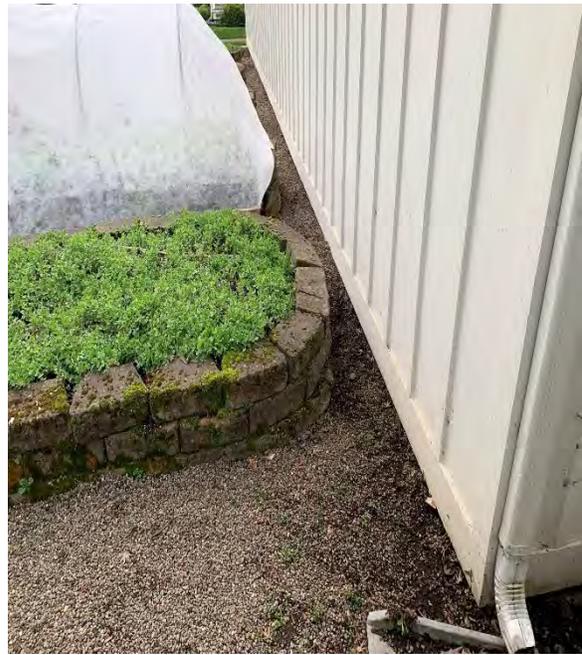
3.3B Another example of inadequate clearance from siding to grade.

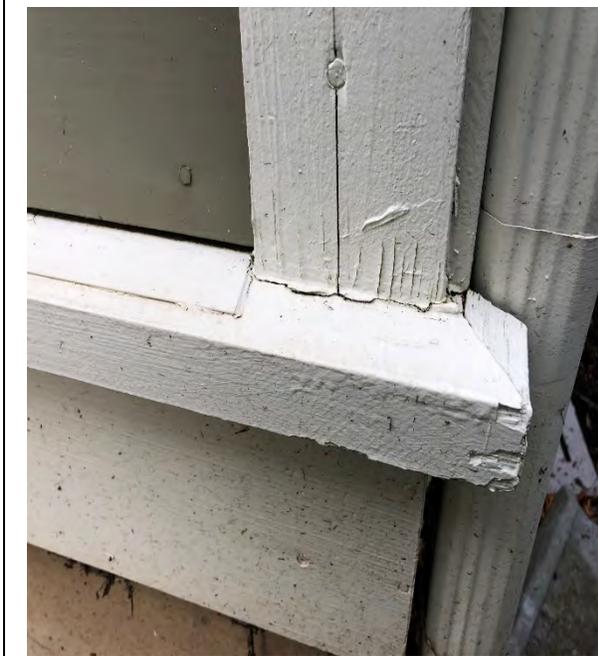
3.4A Trim is deteriorating at many units (#7021, 7022, 7025, 7030, 7034, 7038, 7039, 7042, 7043, 7047, 7051, 7055, 7058, 7059).

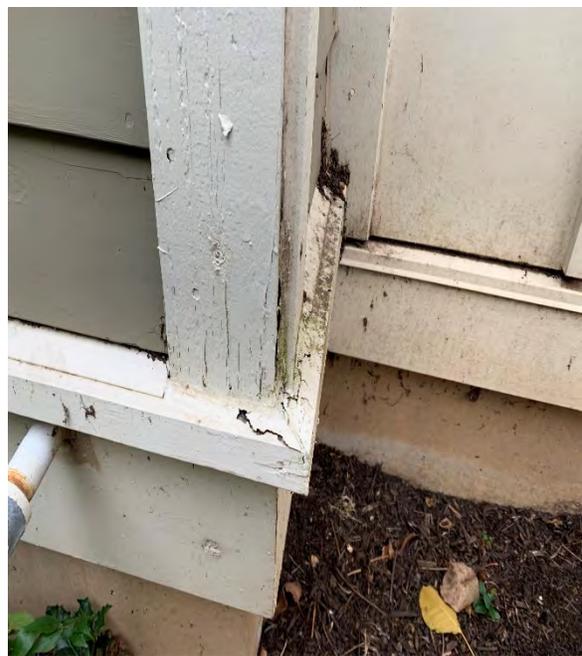
3.4B Another example of deteriorated trim.

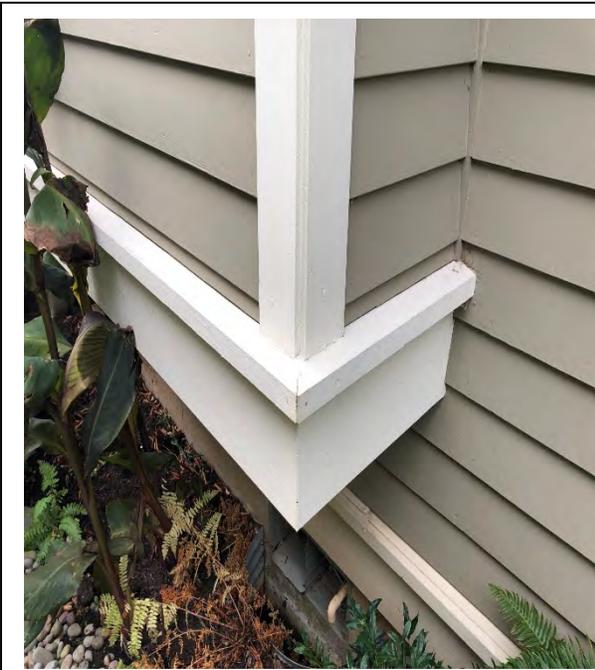
3.5A Flashing at lower trim is omitted at #7021, 7029, 7030, 7033, 7034, 7051, 7054, 7055, and 7063.

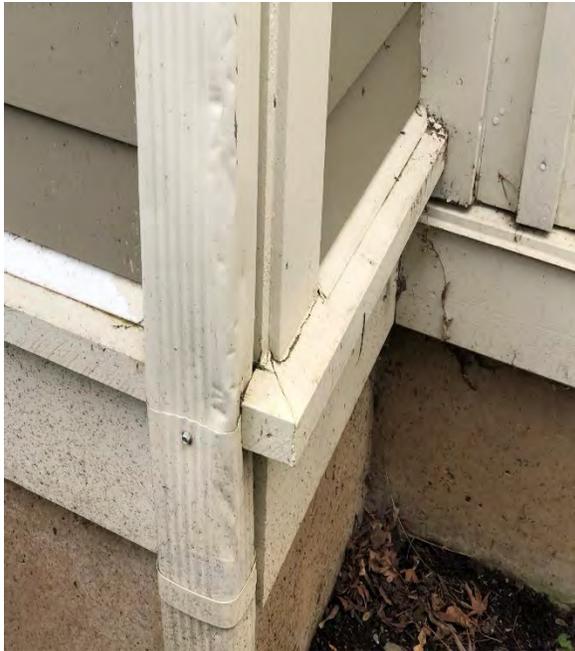
3.6A At most units, the lower trim outside corner is not properly flashed. At #7025, the inside corner is also improperly flashed.

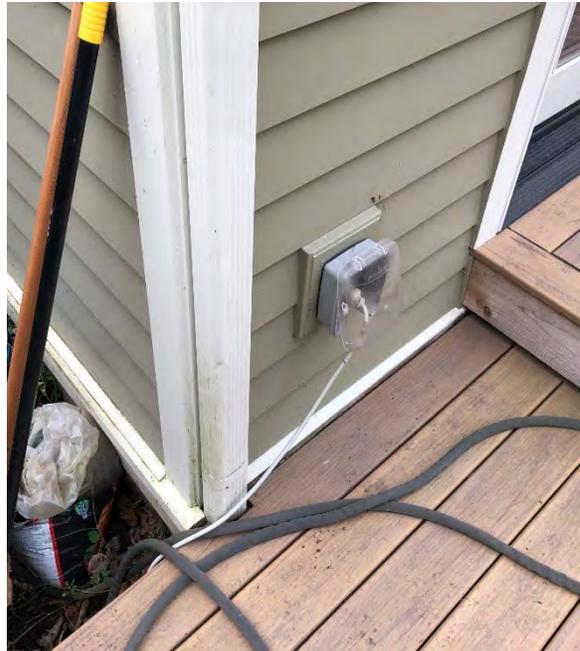
3.6B Another example of improperly flashed outside corner at lower trim.

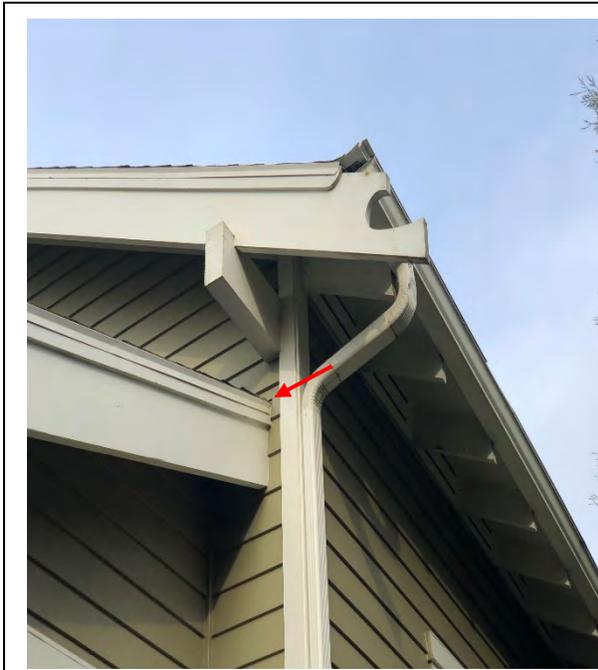
3.7A Flashing is sealant dependent at rake edge/siding of #7022, 7033, 7038, 7039, 7043, 7046, 7047, 7051, 7054, 7055, 7063, and 7071.

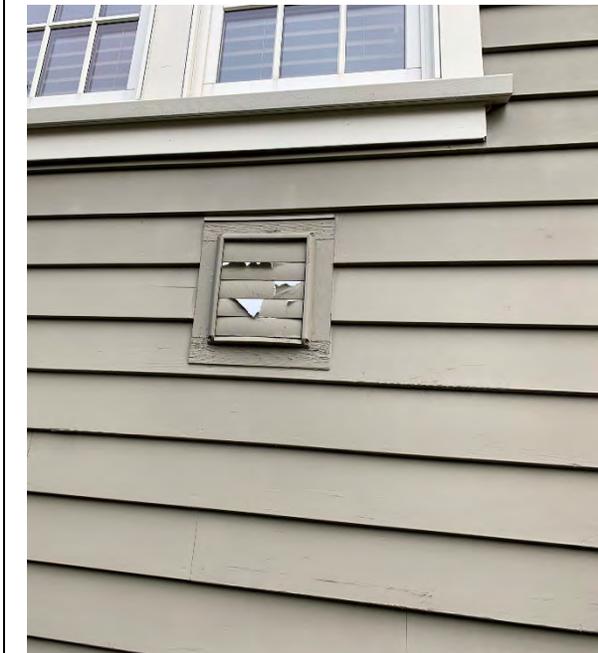
3.8A Exterior vents at #7025, 7029, 7054, and 7067 are broken, missing screws, and/or missing paint.

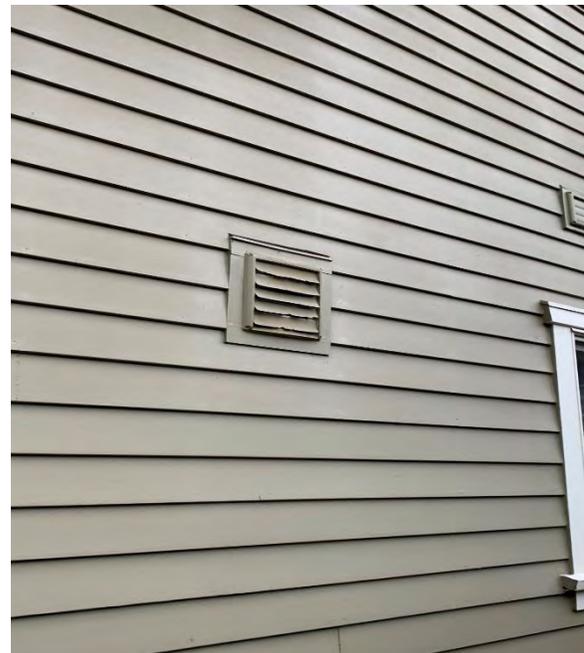
3.8B Another example of damaged exterior vent.

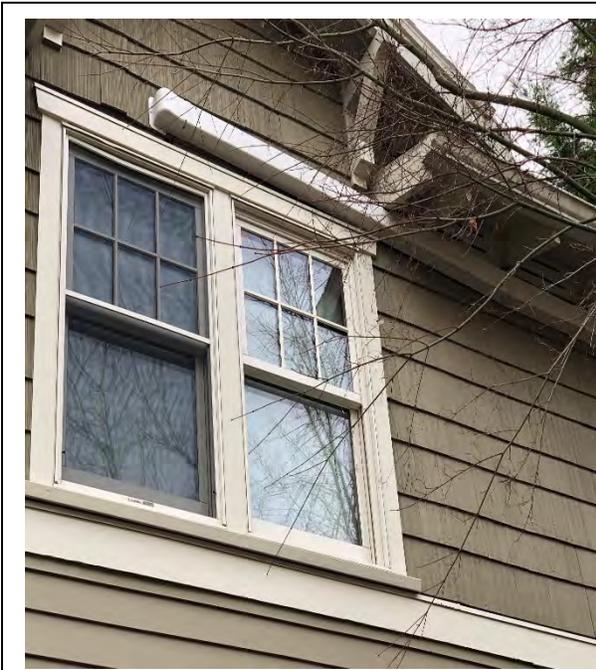
3.9A It is unclear if the area where the HVAC penetration and line hide penetrate through the siding is properly sealed at #7025 and 7046.

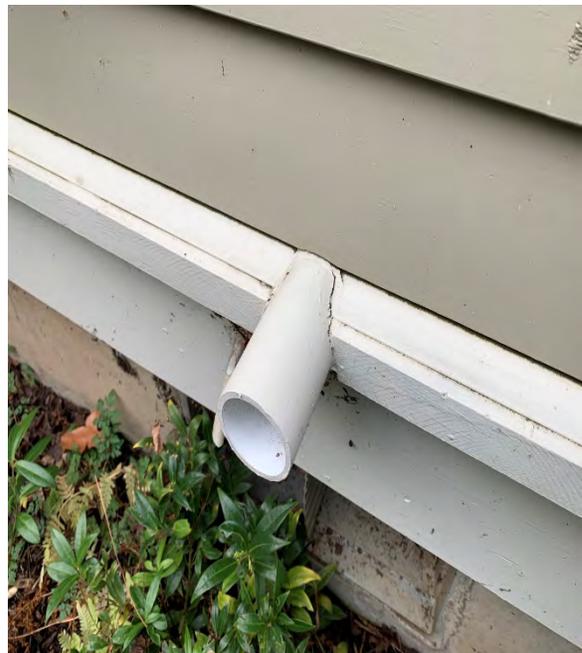
3.10 Flashing/sealant is failing/incomplete at penetration at #7047.

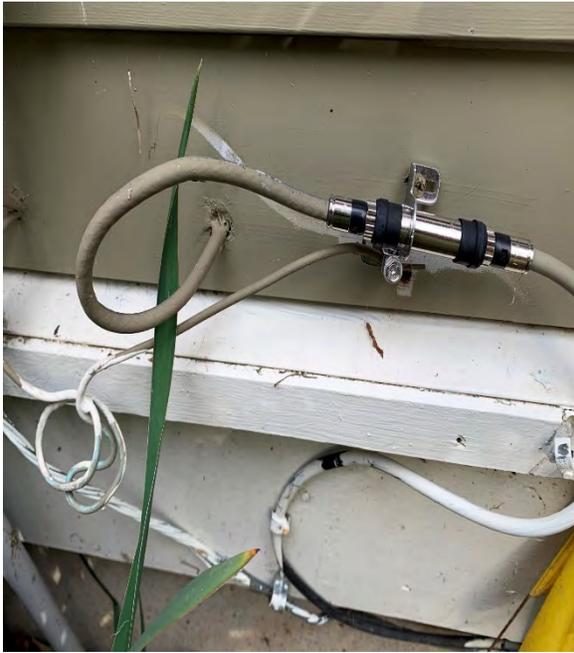
3.11A Cable penetration is not properly sealed at #7026, 7030, 7042, 7046, and 7054.

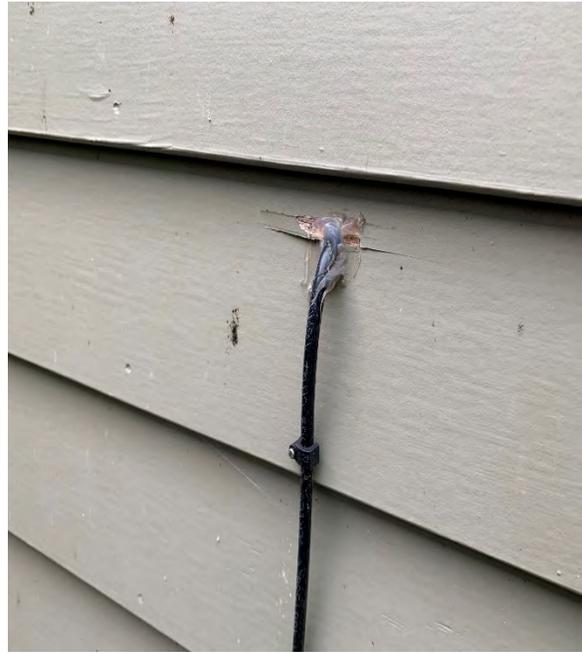
3.11B Another example of improperly sealed cable penetration.

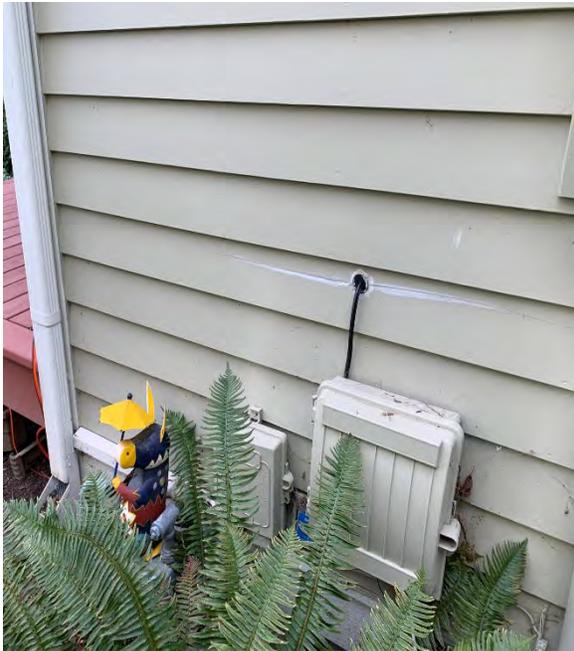
3.11C Another example of improperly sealed cable penetration.

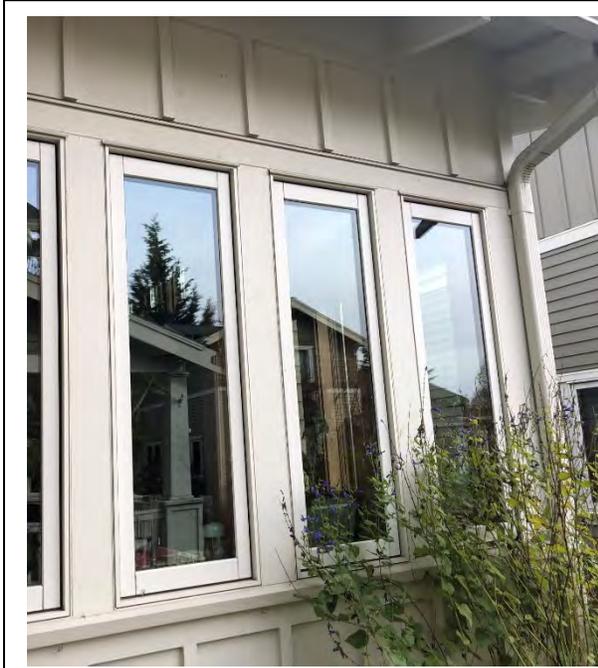
**Windows & Doors:** The main concern is failing sealant at some of the window to trim connections. This is partially due to omission of a performance dynamic sealant joint between the window and trim. There were also some units where the insulated glass unit (IGU) has failed.

4.1A Performance sealant joint is omitted at most windows.

**Windows & Doors:** In areas where sealant is failing, hire qualified contractor to rework sealant. This will be a continuing maintenance item as the joints will not perform as intended at the window to trim connection due to existing installation. When exterior components are replaced in the future, a performance dynamic joint should be installed at these areas.

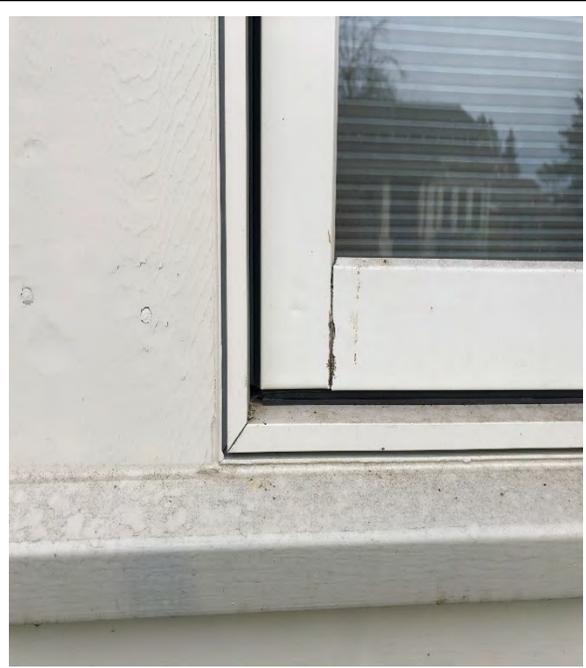
4.1B Closer view of omitted sealant joint.

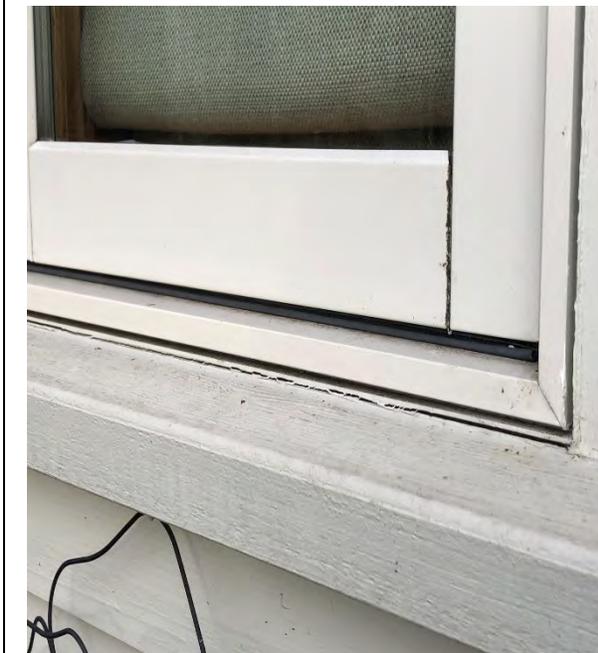
4.2 Flashing is omitted at base of most windows.

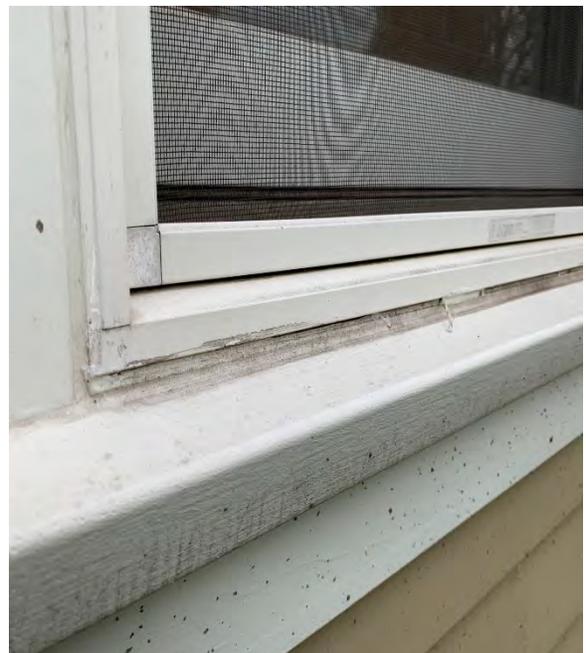
4.3A Sealant at most windows is failing.

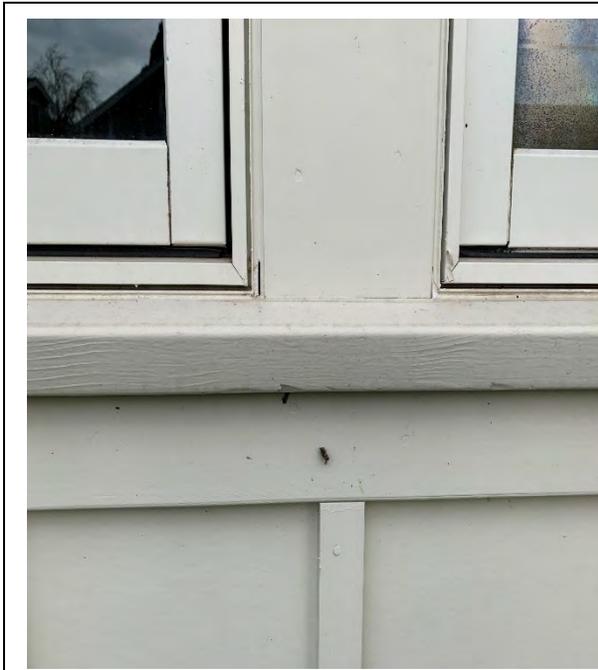
4.3B Another example of failed sealant.

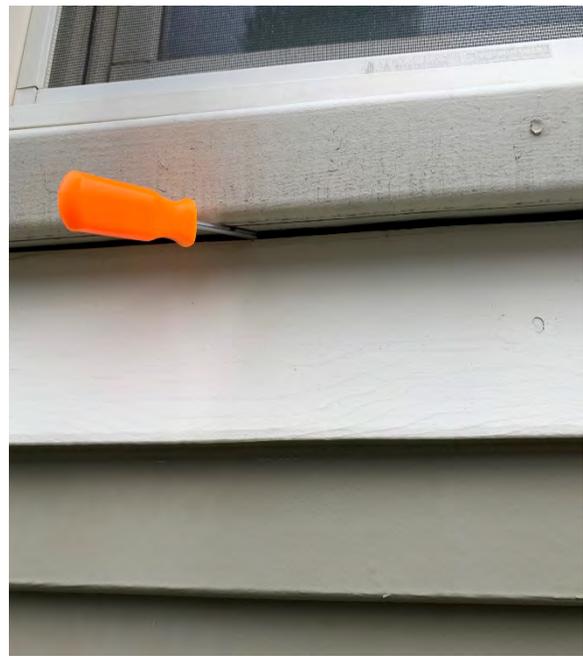
4.4 Sealant at top of siding to window sill is missing at some units (#7021, 7026, 7033, 7034, 7038, 7043, 7055, 7071).

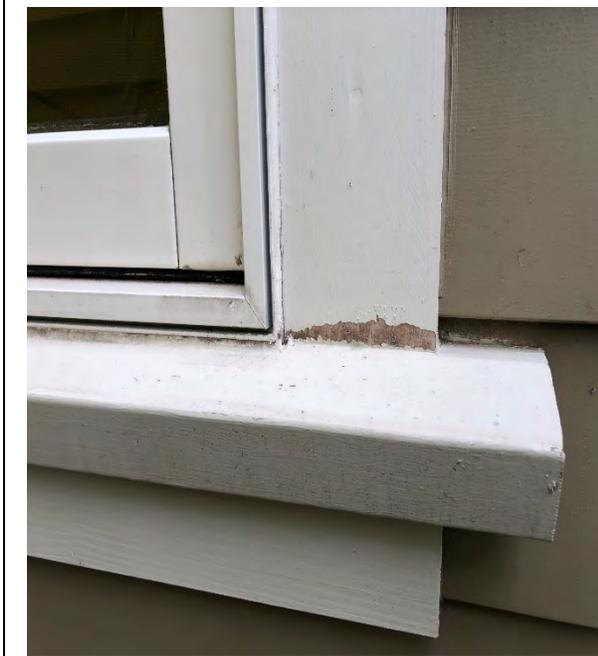
4.5A Window trim paint is missing/cracked at #7021, 7026, 7033, 7034, 7038, 7043, 7055, and 7071.
