# COTTAGES AT HASTINGS GREEN

7021-7071 SE Clinton St, Portland, OR 97206

## EXTERIOR ENVELOPE ASSESSMENT

2019-CHG-001

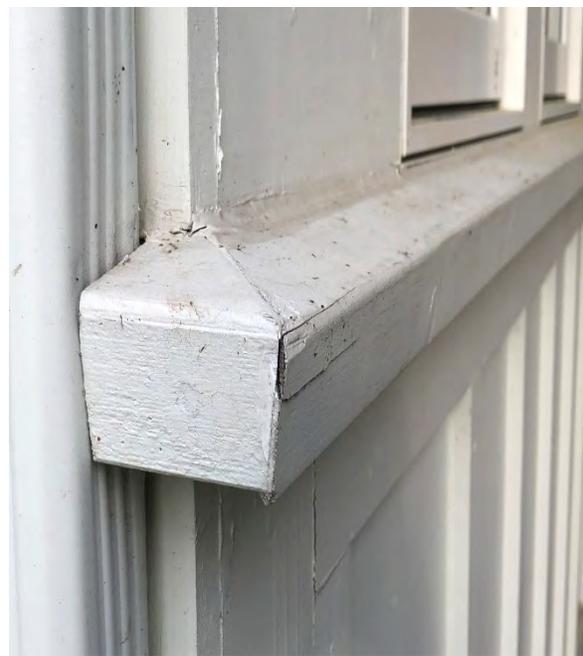
4.5B Another example of damaged window trim paint.

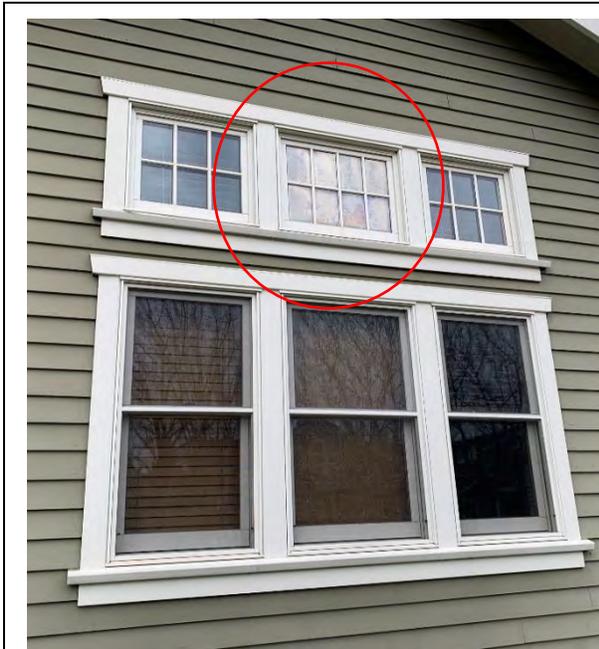
4.6A Insulated glass unit (IGU) has failed at #7022, 7034, 7055, 7058, 7067, and 7071.

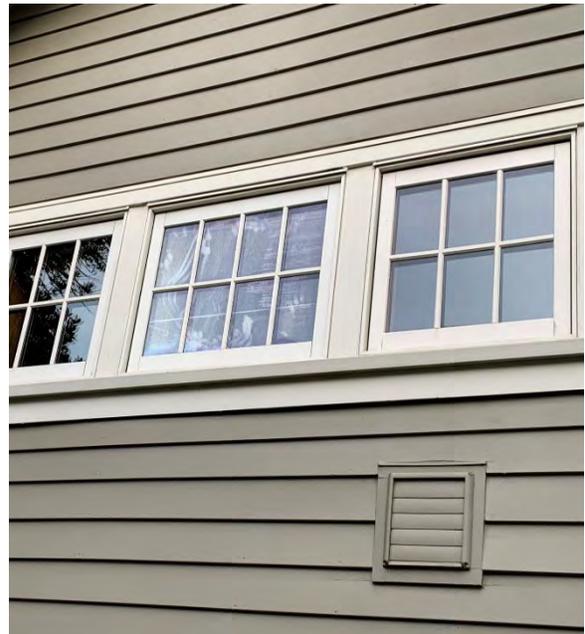
4.6B Another example of failed IGU.

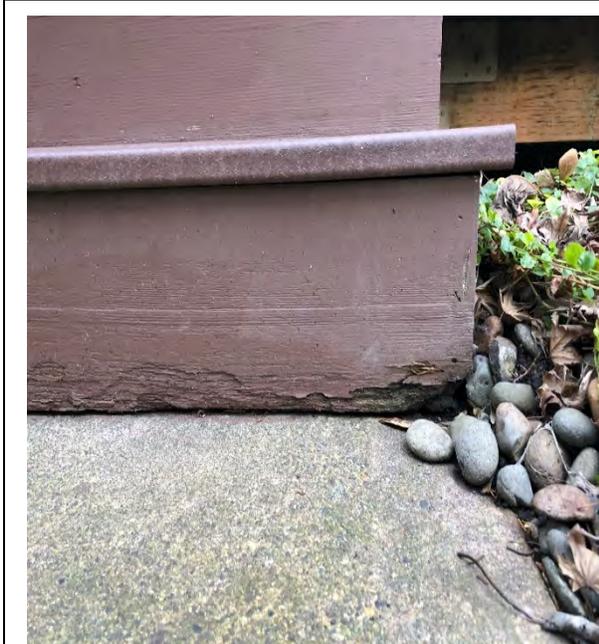
**Decks:** The decks are generally in good condition, except for the kick board at the first step and the columns. At most buildings, the kick board is deteriorating due to being in contact with the ground. Column corner joints are beginning to separate and show signs of decay as well.

5.1A At most units, the kick board at the bottom of front stairs is deteriorating due to contact with sidewalk or grade.

**Decks:** Clean on a regular schedule to help ensure full useful life of deck boards. Hire qualified contractor to replace any decayed kick boards. Ensure a clearance is maintained between bottom of kick board and ground so that these boards do not decay as well. Seal corners of columns that are separating and replace any that are decayed.

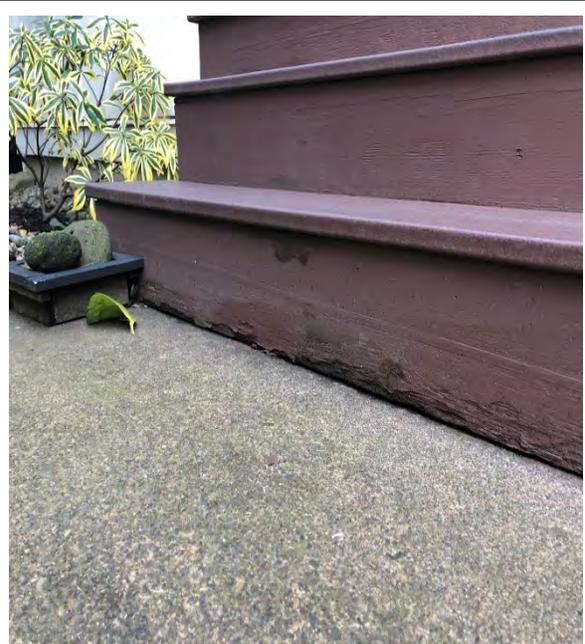
5.1B Another example of deteriorated kick board.

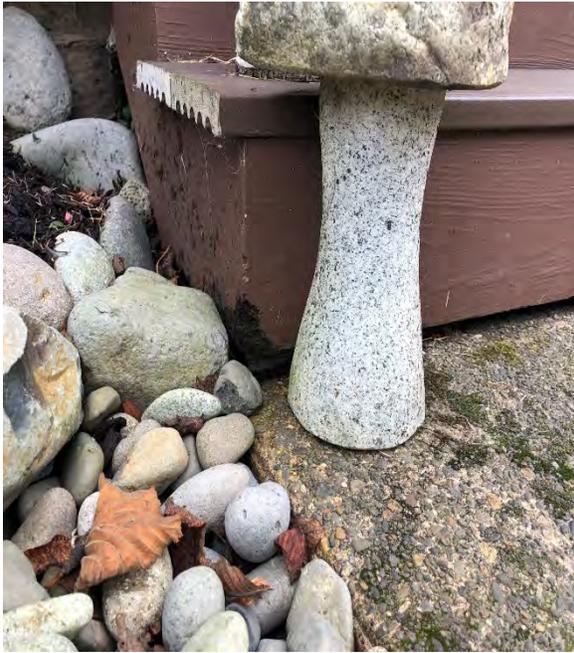
5.1C Another example of deteriorated kick board.

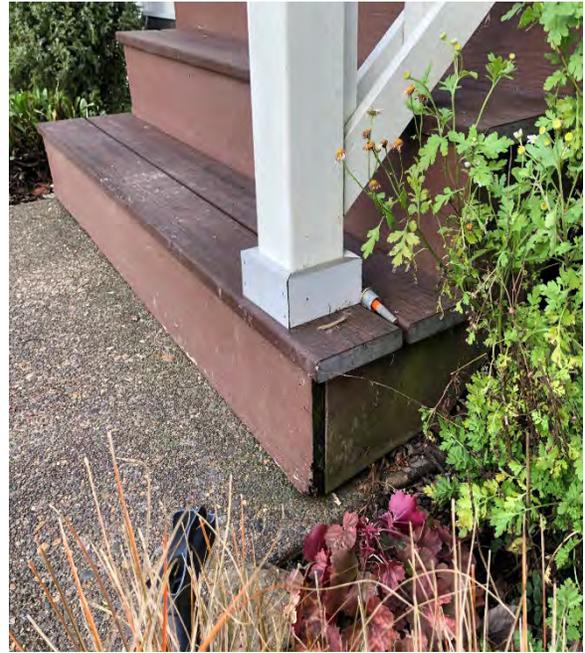
5.1D Another example of deteriorated kick board.

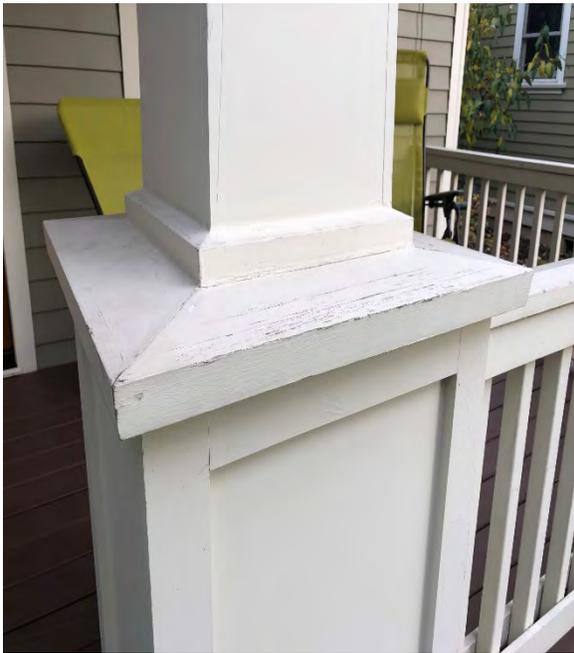
5.2A Column trim paint is peeling and separating at joints at most units.

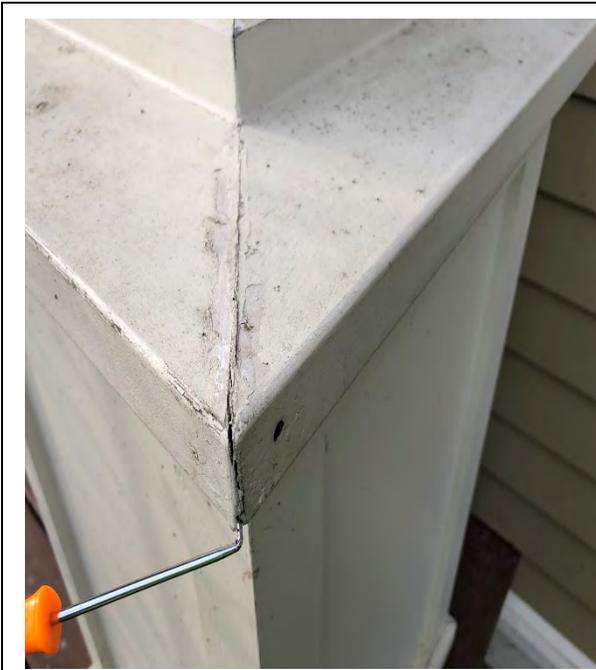
5.2C Another example of column trim separating at joints.

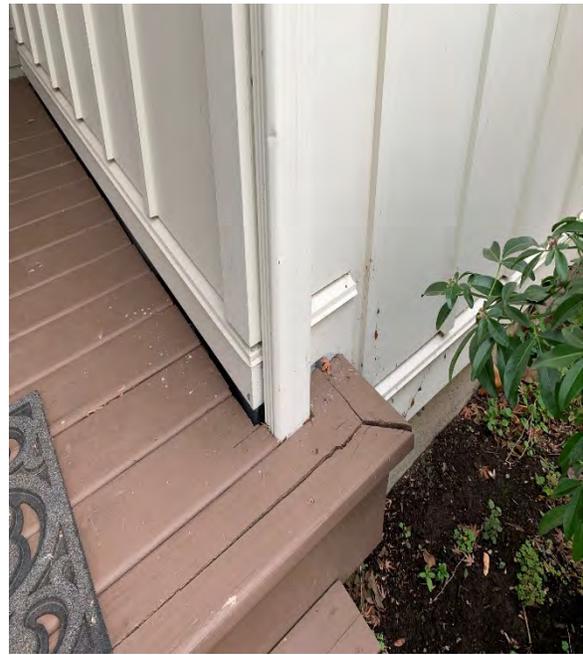
5.3A Deck boards are cracking and showing signs of wear at #7046 and 7055.

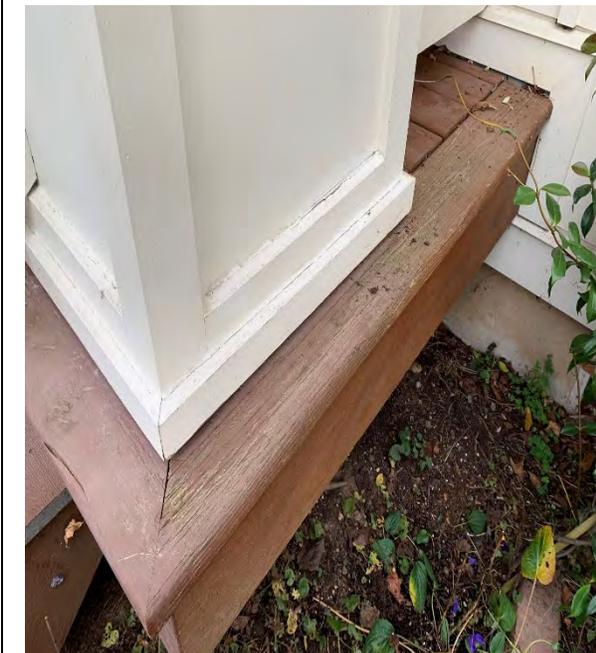
5.3B Another example of worn deck boards.
