COTTAGES AT HASTINGS GREEN

ROOF ASSESSMENT

PONO BUILDING CONSULTANTS

August 11, 2023

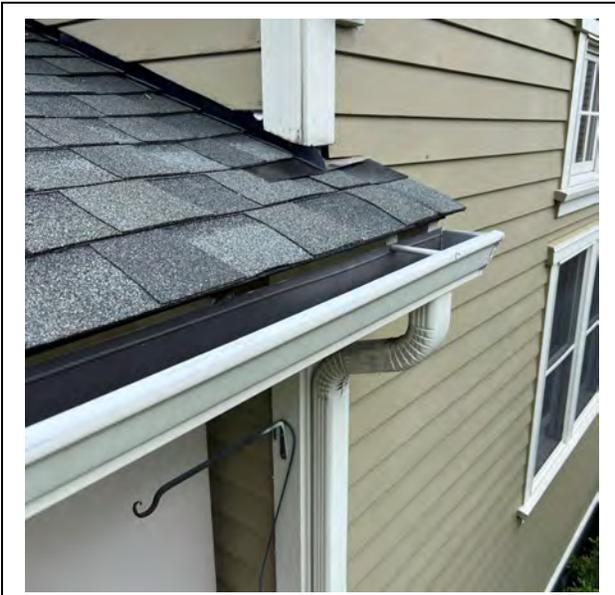
Typical gutter and downspout. Note that replacement of gutters and downspouts was not included in Carlson's scope.

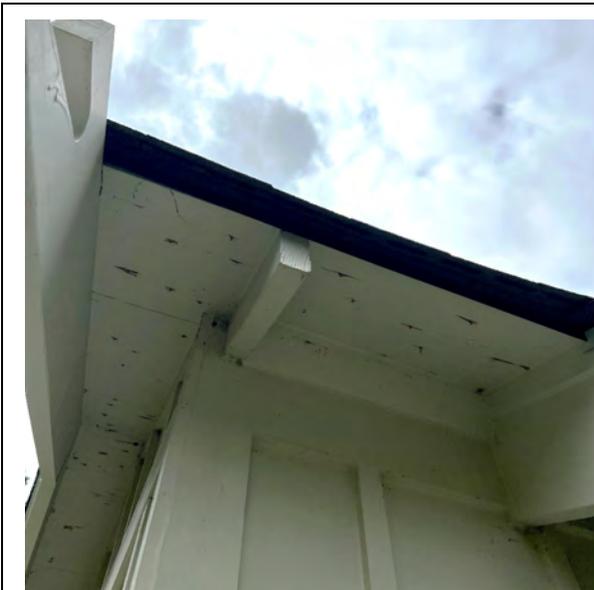
1A. Fasteners penetrate through sheathing at eave.
Location: Systemic throughout property

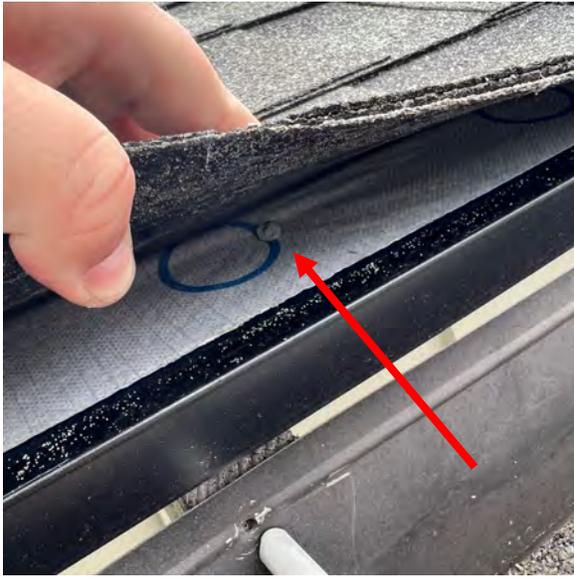
6A. Drip edge flashing fastener penetrates underlayment.

Location: 7021, 7026, 7051, 7071, G6-10

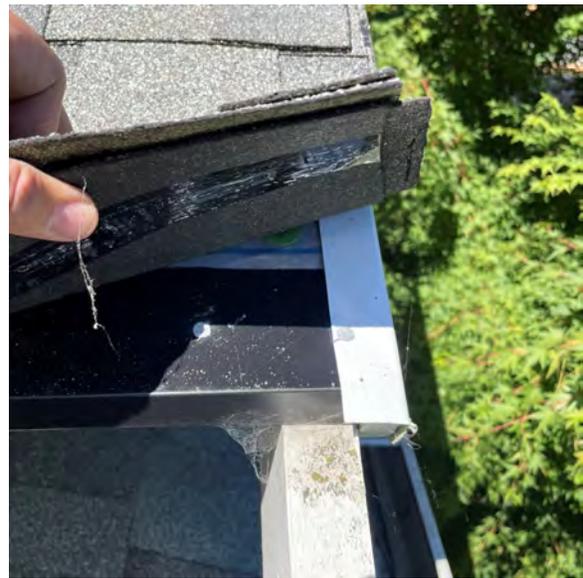
7. Underlayment is improperly lapped under the drip edge flashing, rather than over it.

Location: 7025

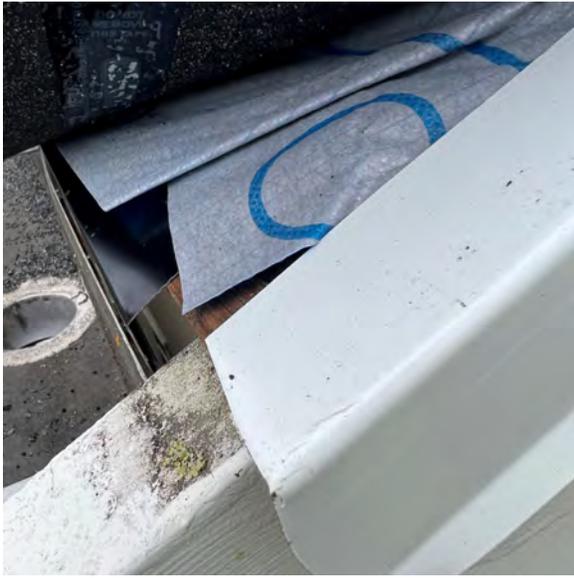
8A. Underlayment is not properly installed or lapped under the rake edge flashing. Drip edge flashing also does not fully extend to edge of roof.

Location: 7030, 7043, 7047, 7050, 7051, 7055, 7071

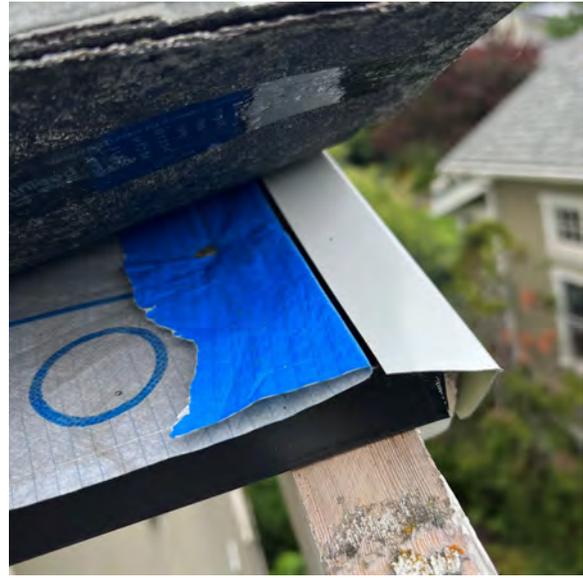
8B. Additional example of improperly installed underlayment.

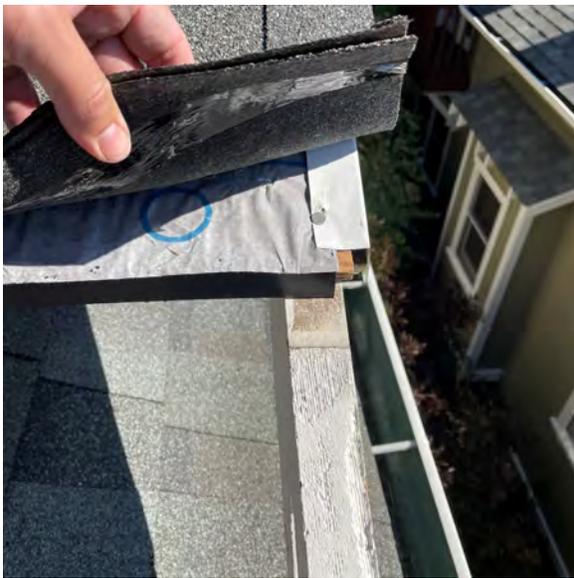
9. Underlayment does not extend to the rake edge.

Location: 7076

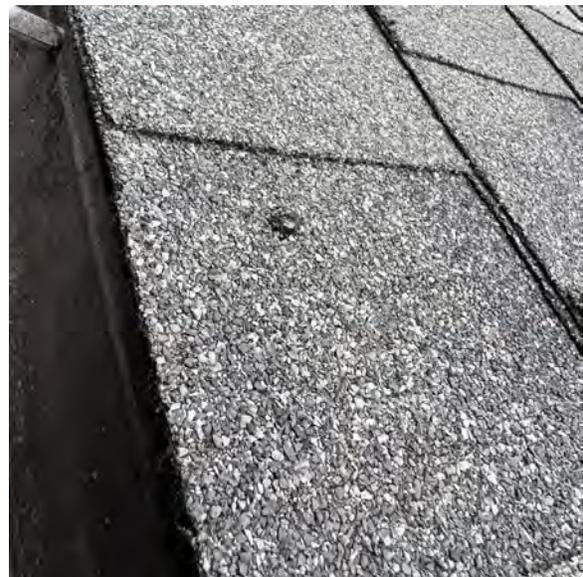
21A. Nail improperly installed through shingle.
Location: 7026, 7034

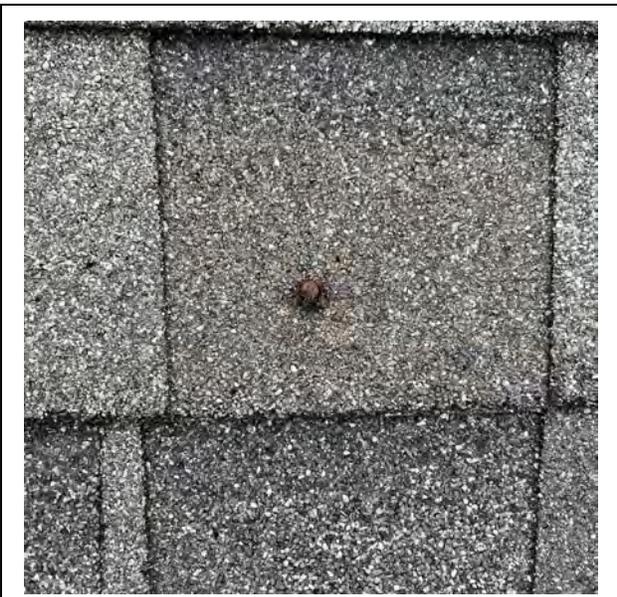
21B. Additional example of nail installed through shingle. Also note, nail is corroded.

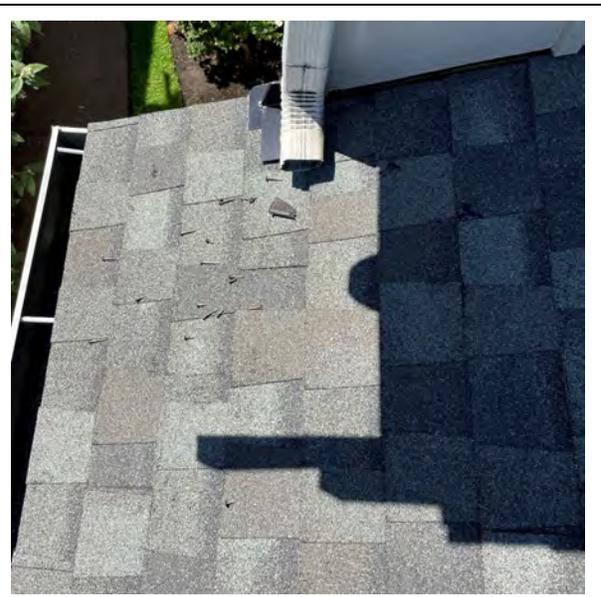
22. Roofing nails and other debris present on roof from previous shingle installation.
Location: 7051

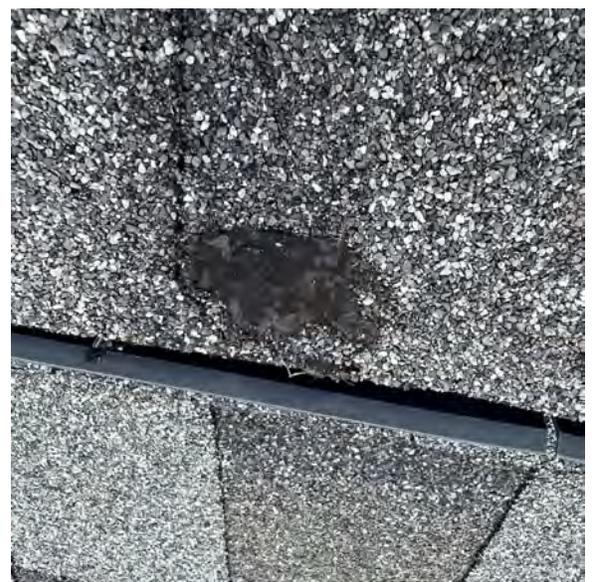
23B. Additional example of improperly sealed exposed fastener.

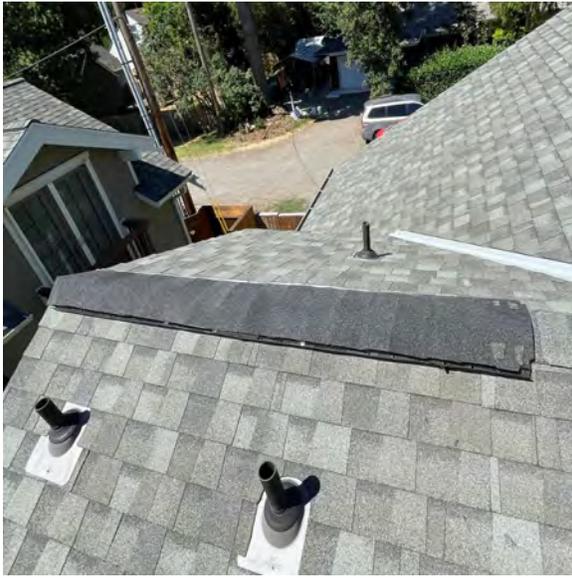
24. Shingles installed at ridge vent are different color.
Location: 7033

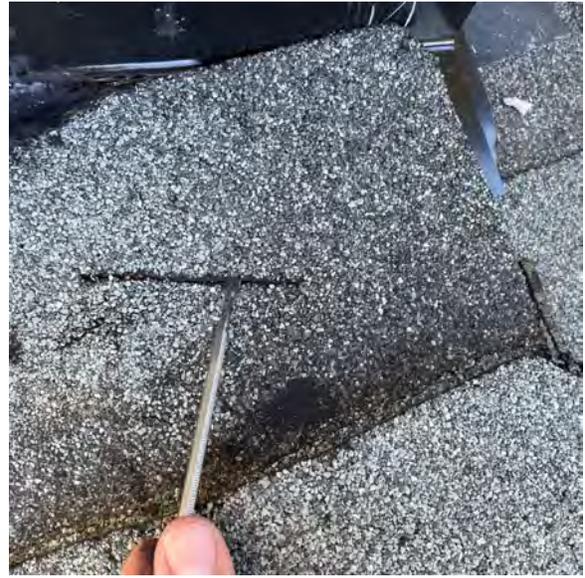
25. Shingle is damaged.
Location: 7025

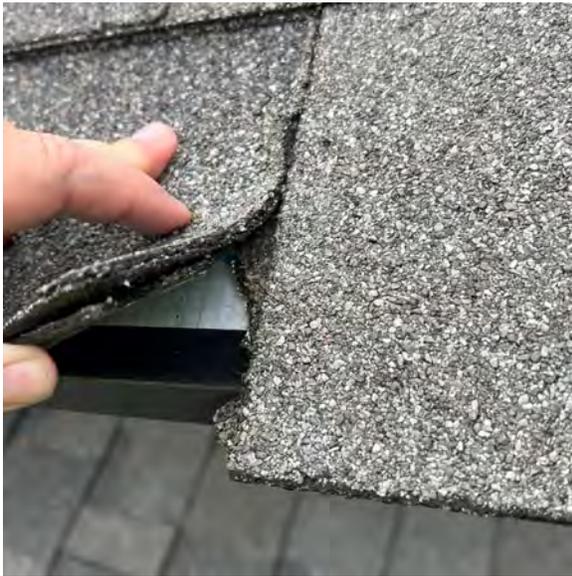
26. Starter strip is damaged at drip edge.
Location: 7046

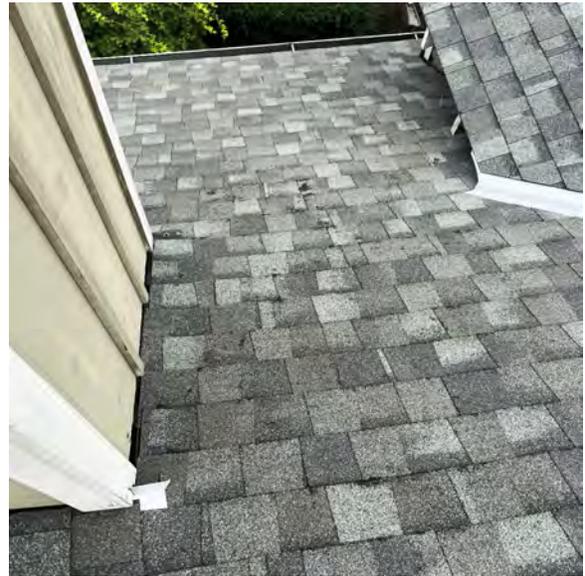
27A. Shingles are scuffed, likely caused by walking on the shingles on hot days during installation.
Location: 7011, 7022, 7030, 7046, 7054, 7055, 7059

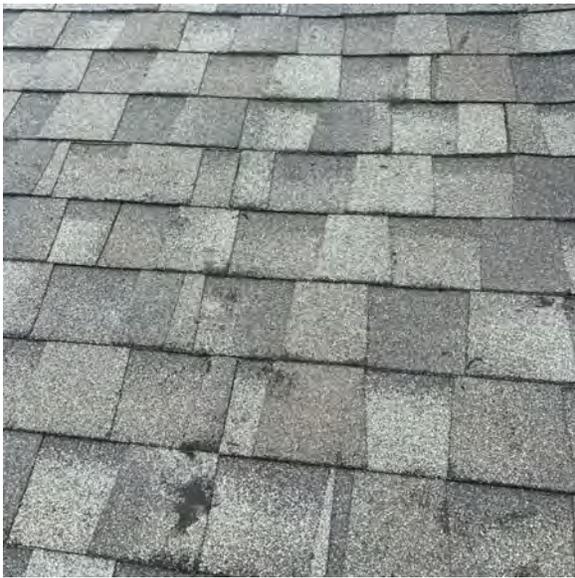
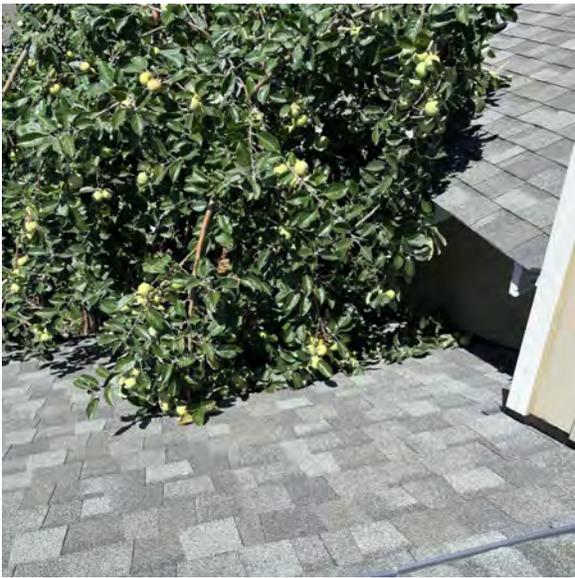
<p>27B. Closer view of scuffed shingles.</p>	<p>28. Vegetation is in direct contact with shingles. A minimum 6' gap should be maintained. Location: 7025</p>

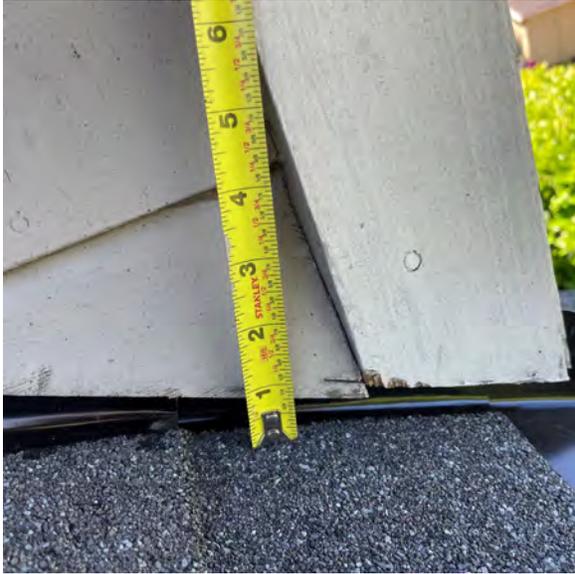
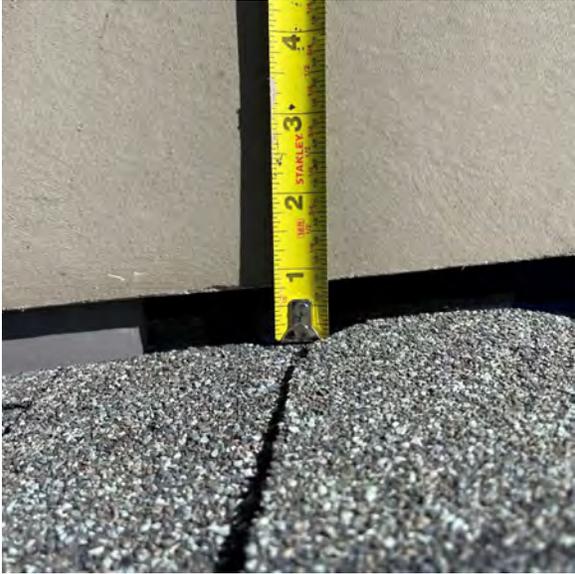
<p>30B. Additional example inadequate clearance between shingles and siding.</p>	<p>30C. Additional example inadequate clearance between shingles and siding.</p>

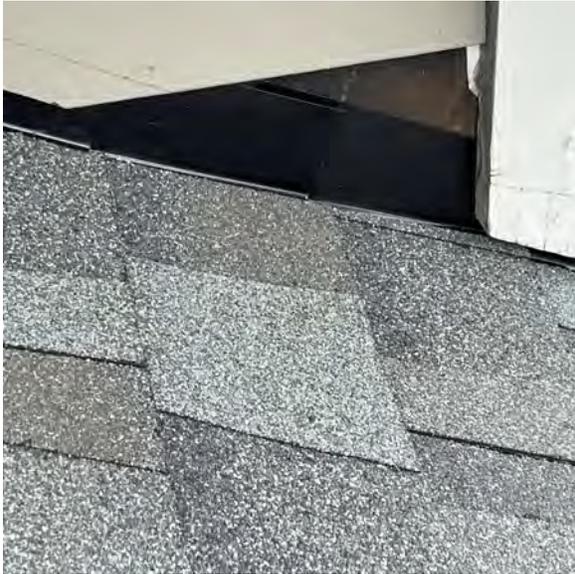
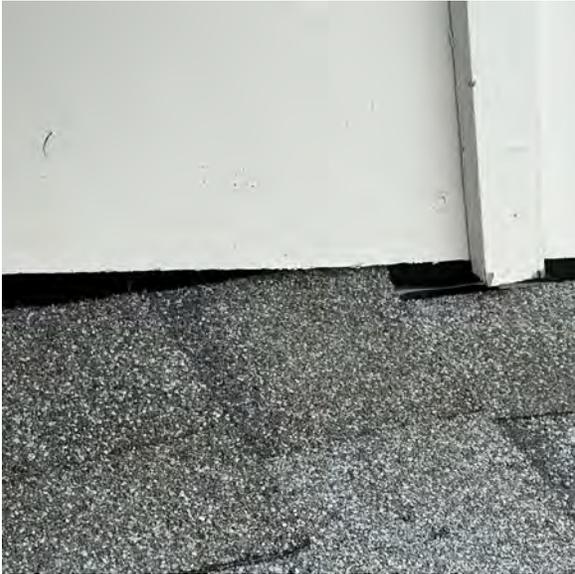
<p>31. Step flashing is reverse lapped with existing weather-resistant barrier (WRB). Location: 7055</p>	<p>32A. Shingles are installed too close to the step flashing. PONO recommends a 1" gap between step flashing and shingles to facilitate proper drainage. Location: Systemic throughout property</p>

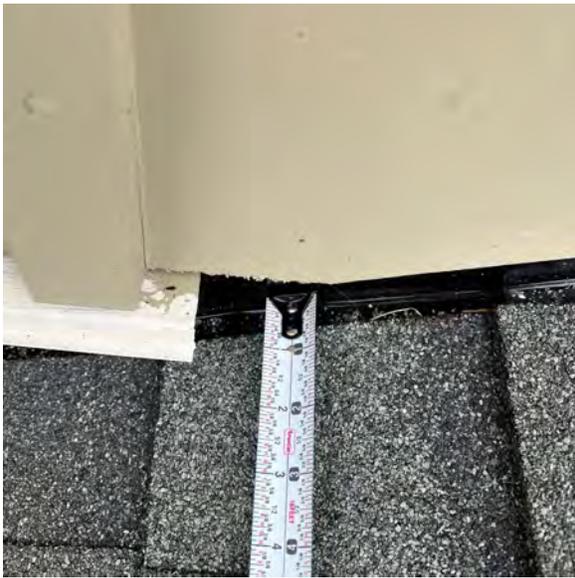
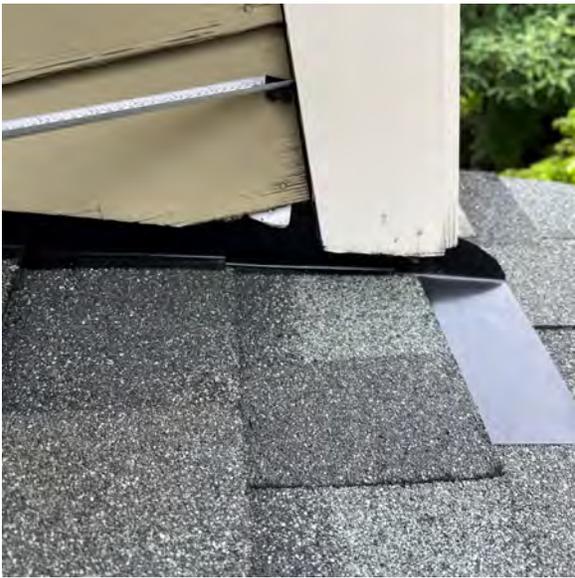
<p>32B. Additional example of inadequate space between step flashing and shingles.</p>	<p>33A. 2" step flashing is installed. Contractor's bid called for 8"x8" step flashing to be installed. Location: 7030, 7033, 7058, 7076</p>

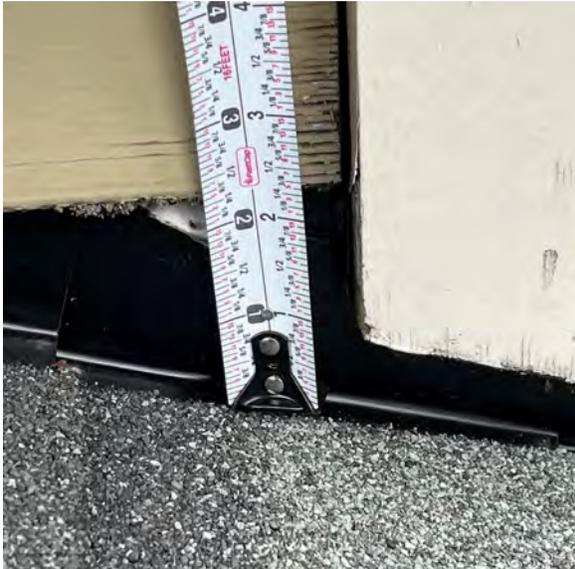
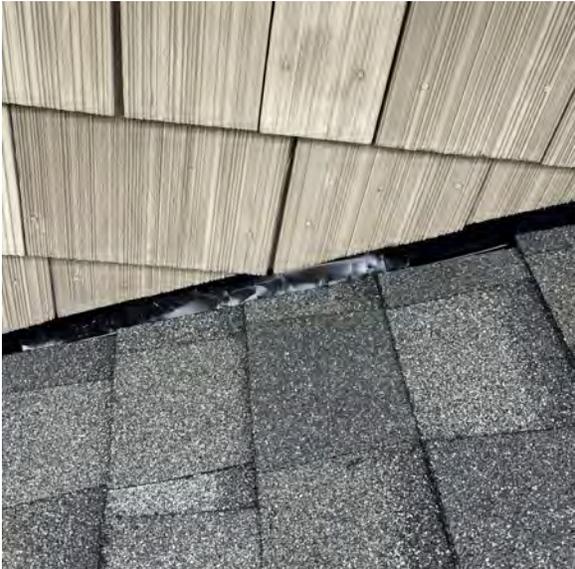
<p>33B. Closer view of incorrect size step flashing.</p>	<p>34. Step flashing is damaged. Location: 7046</p>

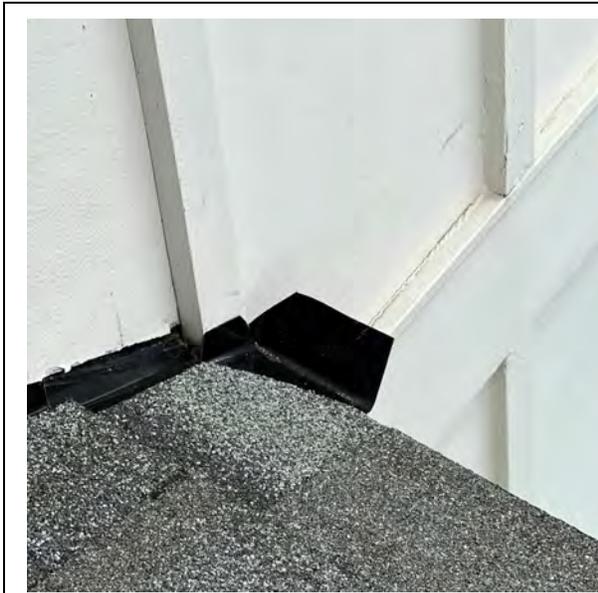
35. Step flashing and diverter flashing are not properly integrated.
Location: G1-5

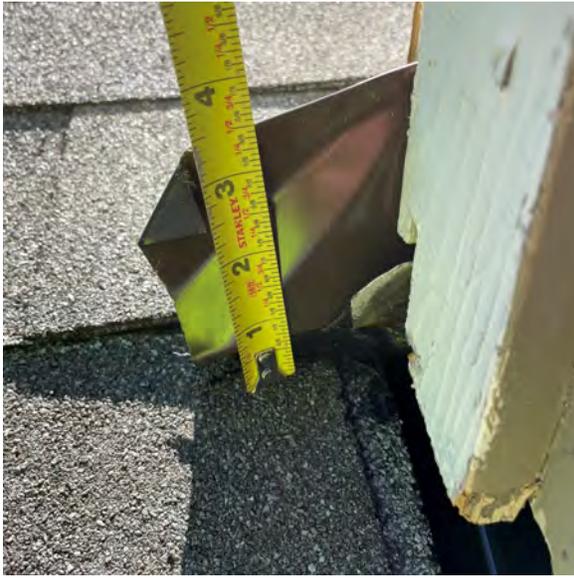
37B. Additional example of improperly sized diverter flashing

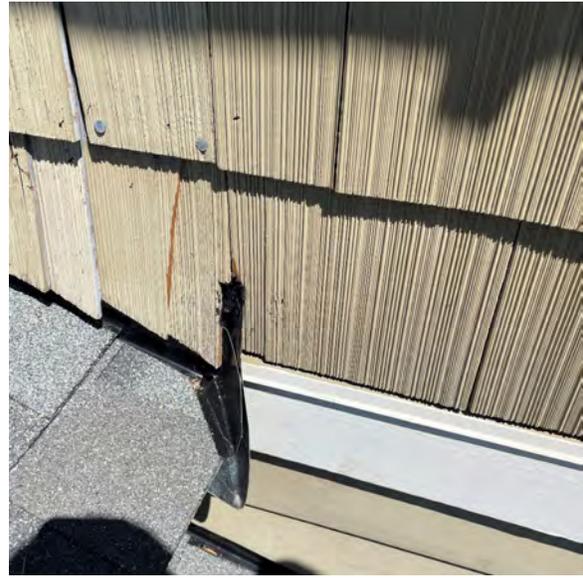
38. Diverter flashing is poorly installed and not properly integrated.
Location: 7025

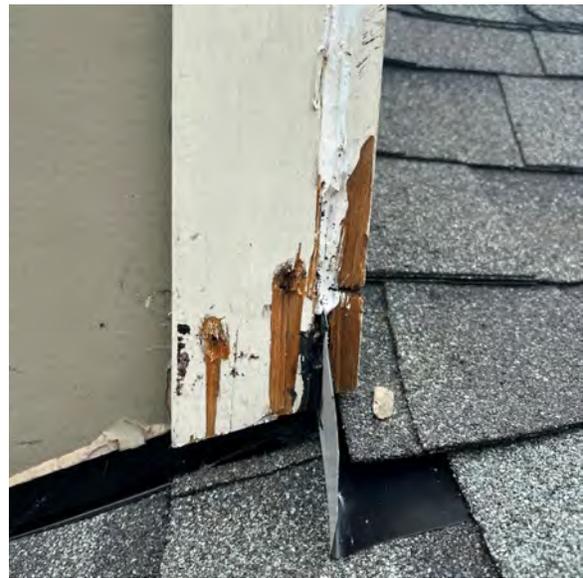
40A. Corner trim is damaged. Damage appears to be new, and likely occurred during the roof installation.
Location: 7030, 7046

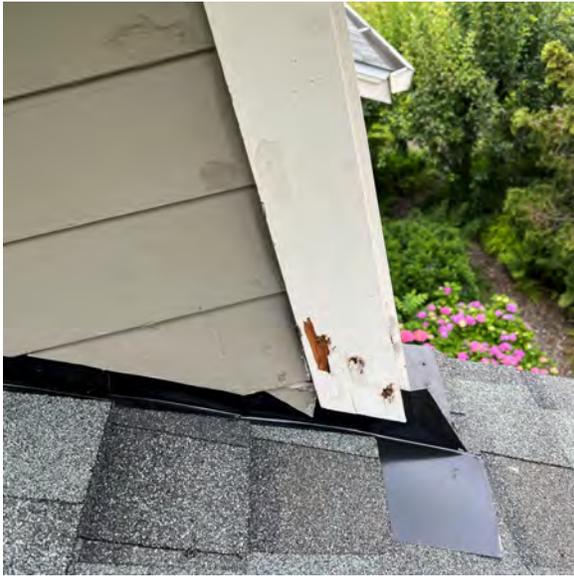
40B. Additional example of damaged corner trim.

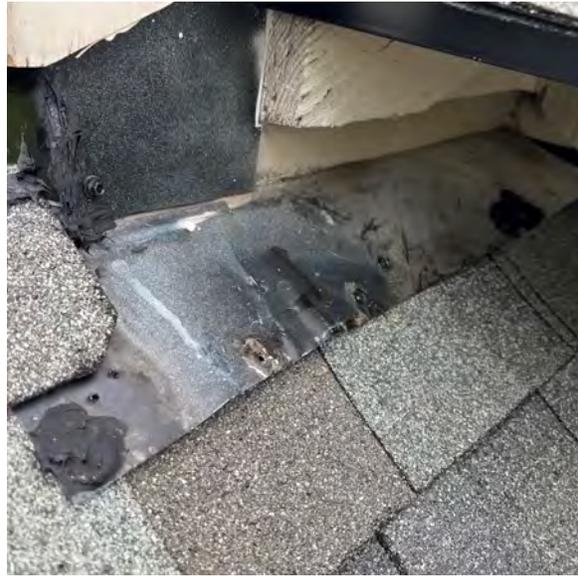
41. Apron flashing fasteners are omitted.
Location: 7026, 7038, 7054

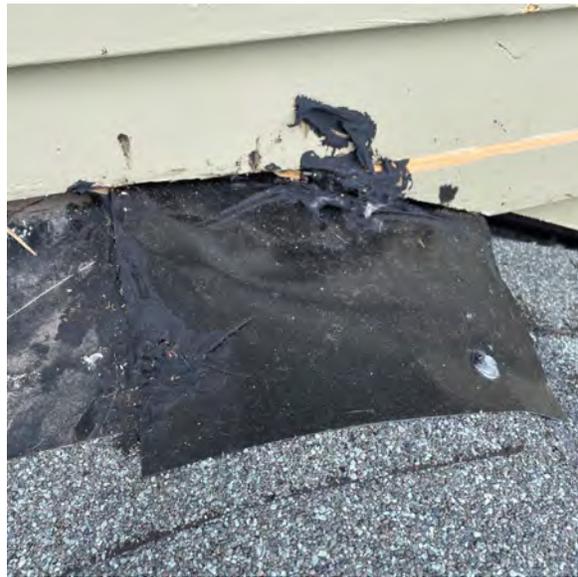
43. Sealant is failing at apron flashing.
Location: 7063

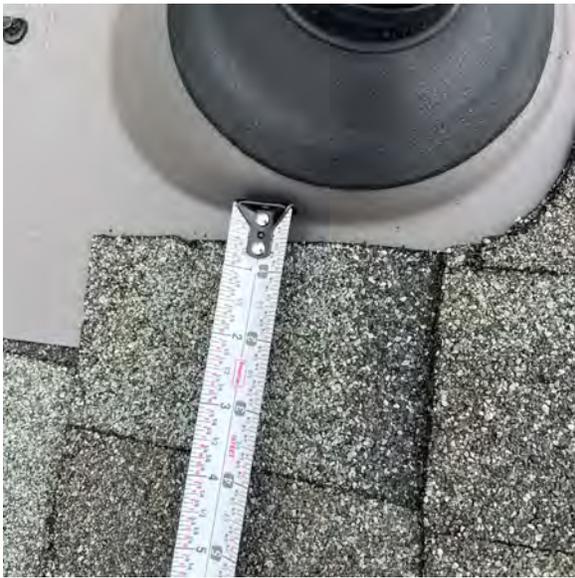
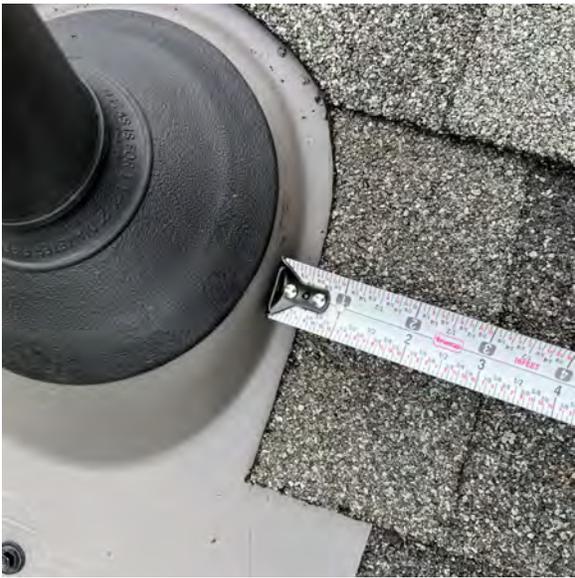
<p>44A. Gap between penetration flashing and shingles is less than 1". A minimum 1" gap between flashing and shingles should be maintained to facilitate proper drainage. Location: Systemic throughout property</p>	<p>44B. Additional example of inadequate gap between flashing and shingles.</p>

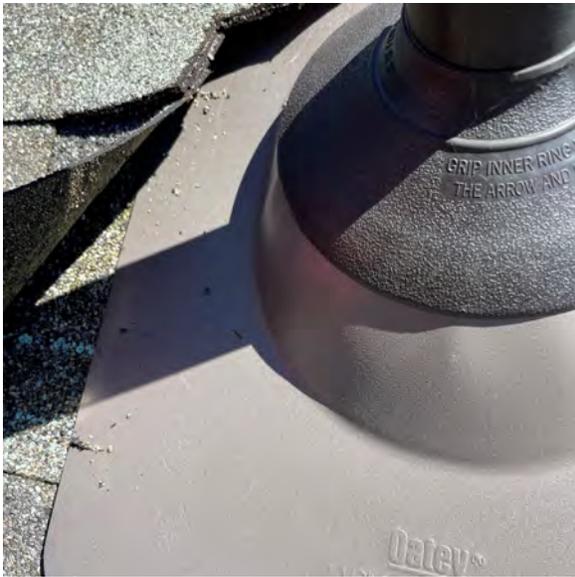
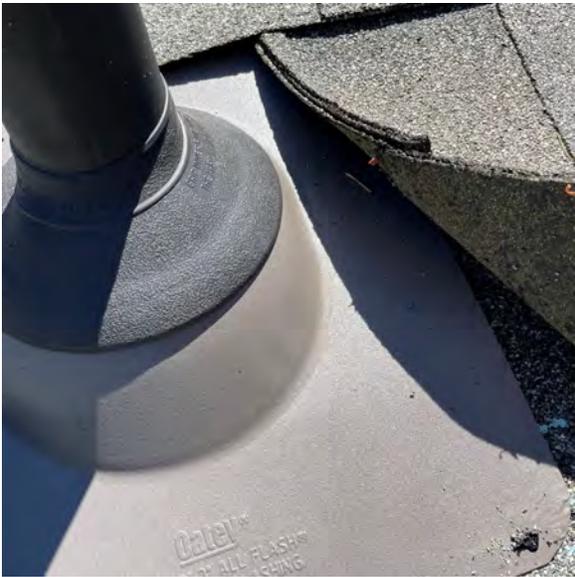
<p>45. Ice and water shield omitted at penetration flashing. Location: 7047</p>	<p>46. Fasteners omitted at back leg and sides of penetration flashing. Location: 7029</p>

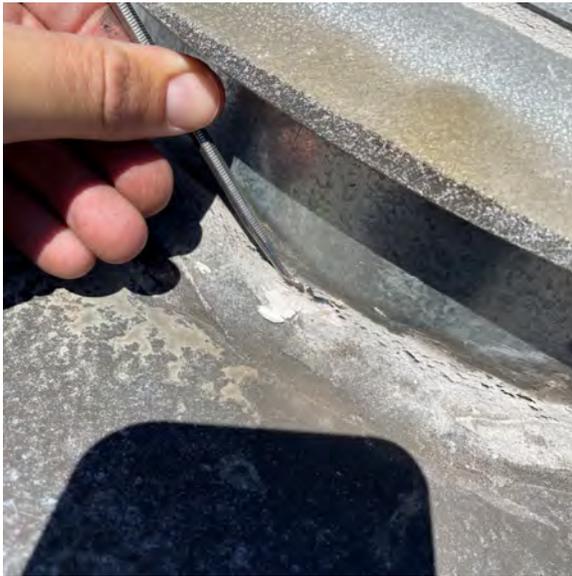
53. Sealant is failing at chimney cap.
Location: 7071

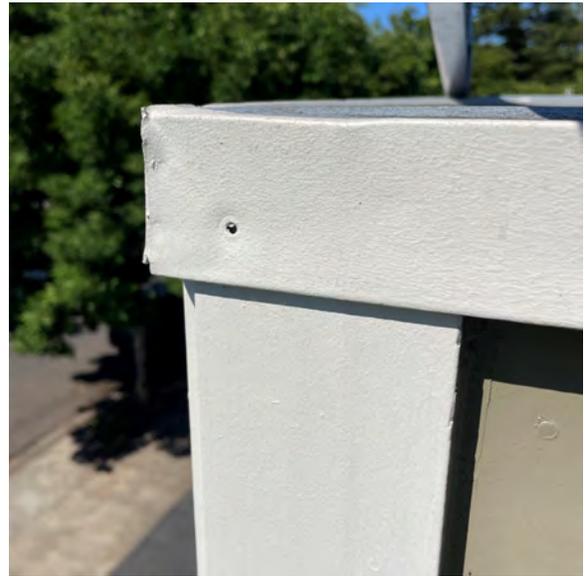
54. Chimney cap fastener is missing.
Location: 7071

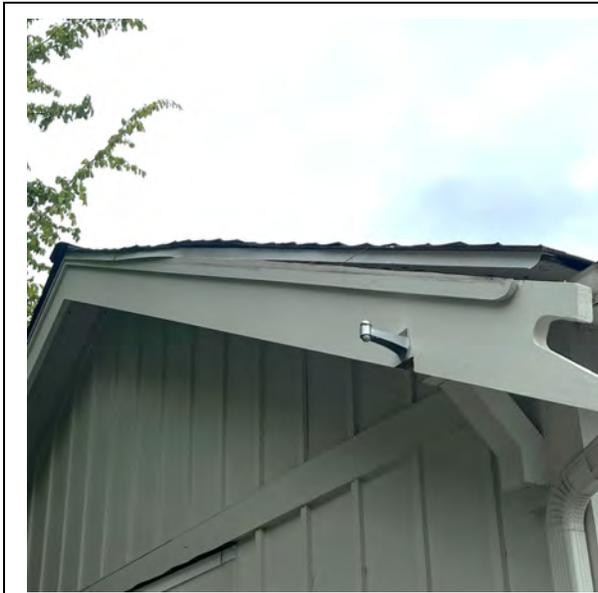
55. Rake metal improperly installed at barge board. Barge board also appears to have moved out of place.
Location: G6-10

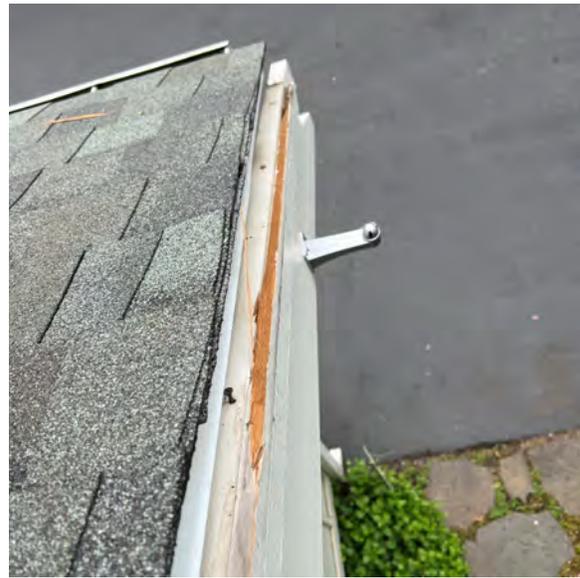
56. Barge board is damaged.
Location: G6-10

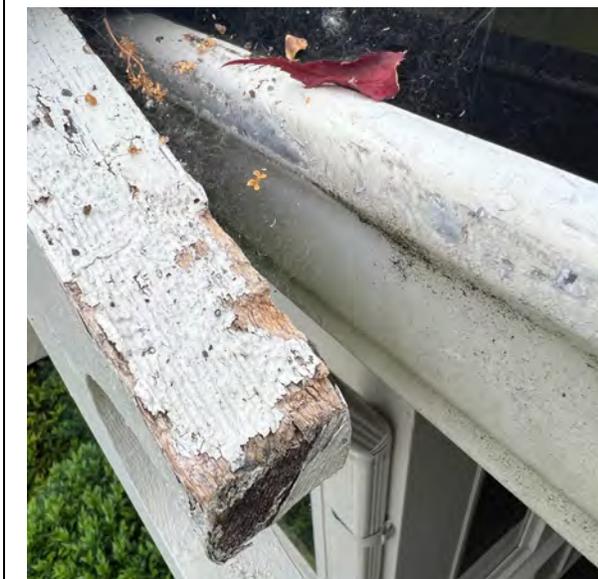
57. Barge board is decayed.
Location: 7030, 7039, 7071

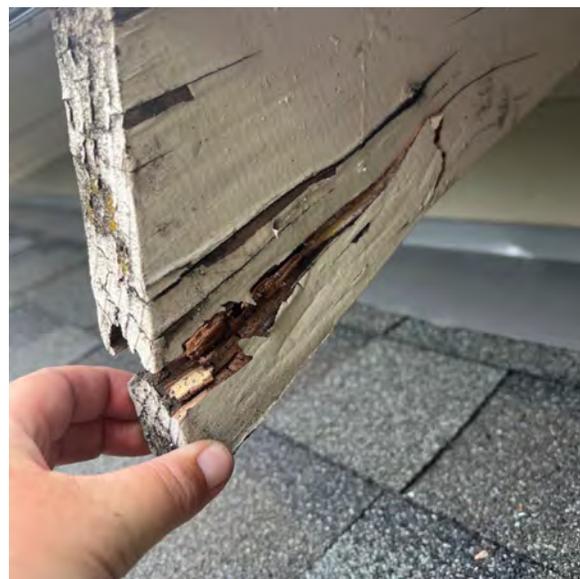
58. Rafter tail is significantly decayed.
Location: 7026, 7055

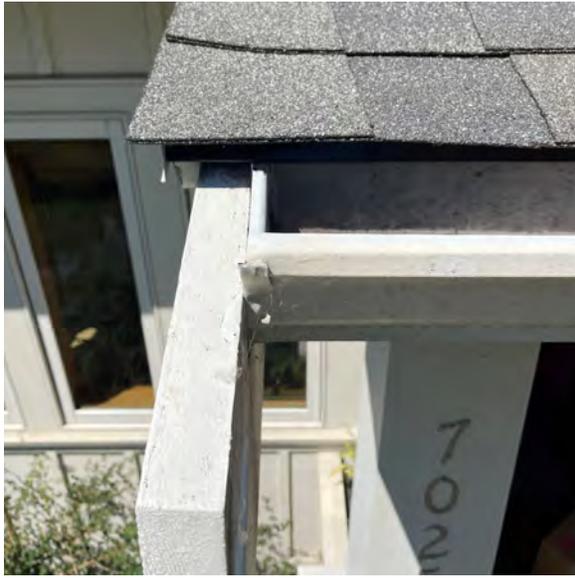
59A. Gutter end cap is installed too close to barge board. A minimum 1" gap should be present.

Location: Systemic throughout property

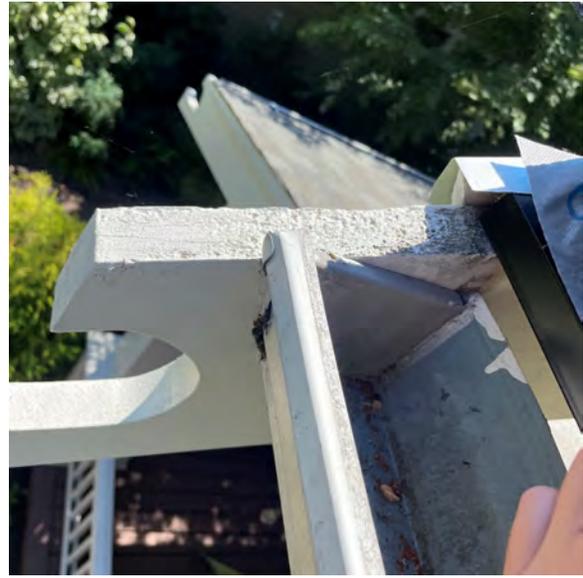
59B. Additional example of inadequate space between gutter end cap and barge board.

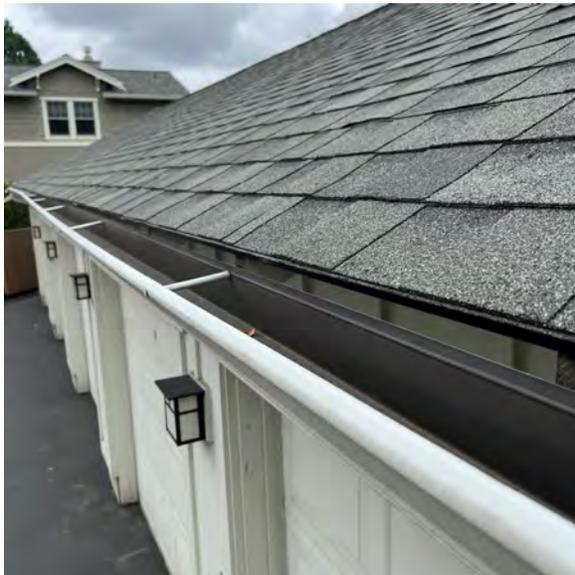
60A. Gutter is not properly secured and has pulled away from the drip edge.

Location: Systemic throughout property

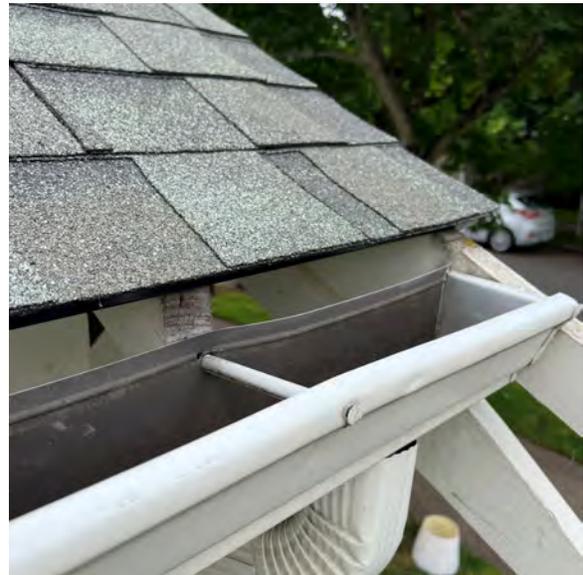
60B. Closer example of improperly secured gutter.

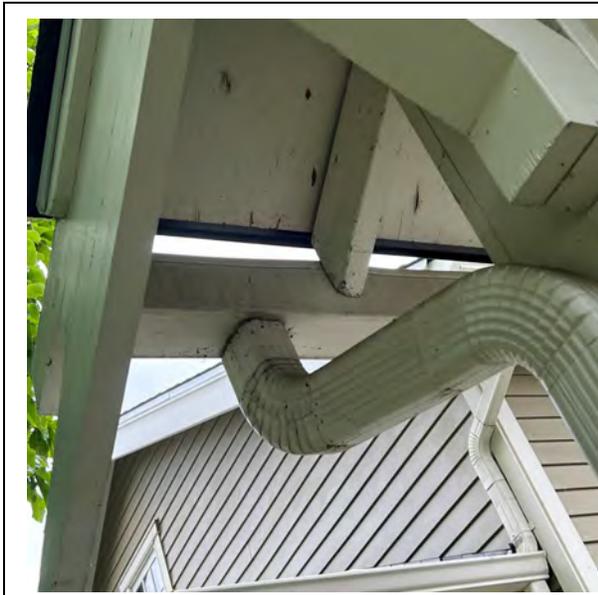
60C. Closer example of improperly secured gutter.

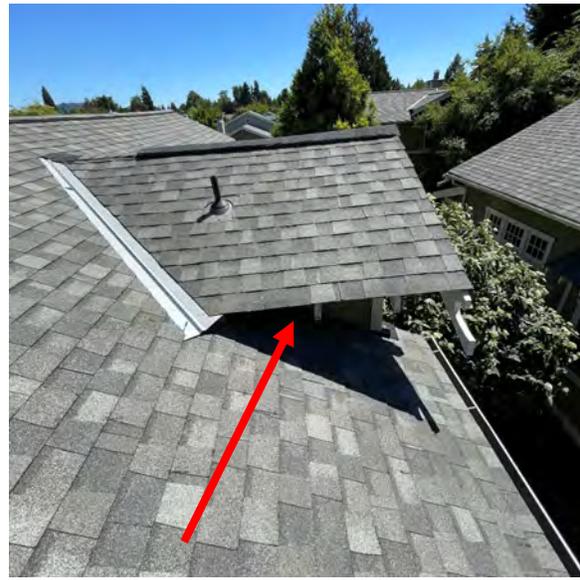
61A. Gutter omitted from upper dormer drip edge.

Location: Systemic throughout property

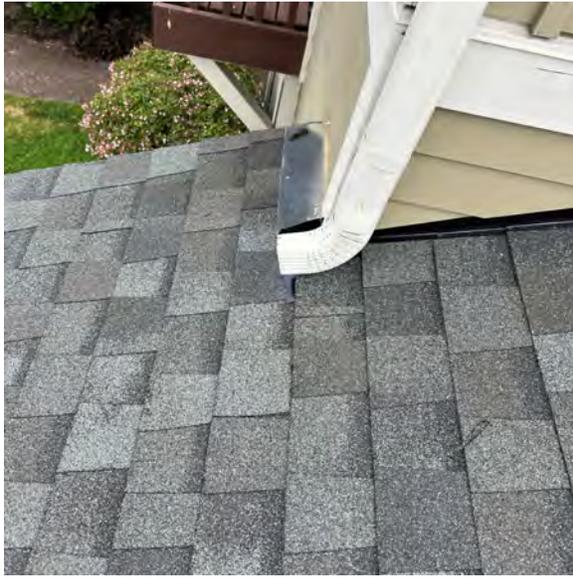
67A. Downspouts drain directly onto lower roofs instead of connecting to lower gutter. This can contribute to premature degradation of shingles.
Location: Systemic throughout property

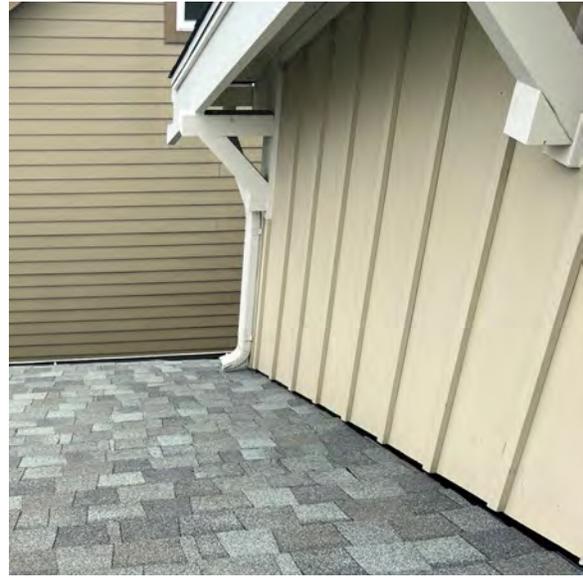
67B. Additional example of downspout draining directly onto lower roof.
