# COTTAGES AT HASTINGS GREEN

7021-7071 SE Clinton St, Portland, OR 97206

## EXTERIOR ENVELOPE ASSESSMENT

2019-CHG-001

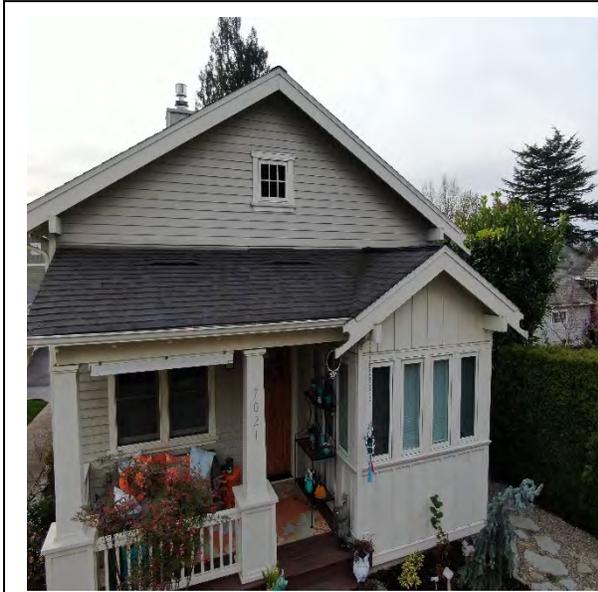
Typical front elevation

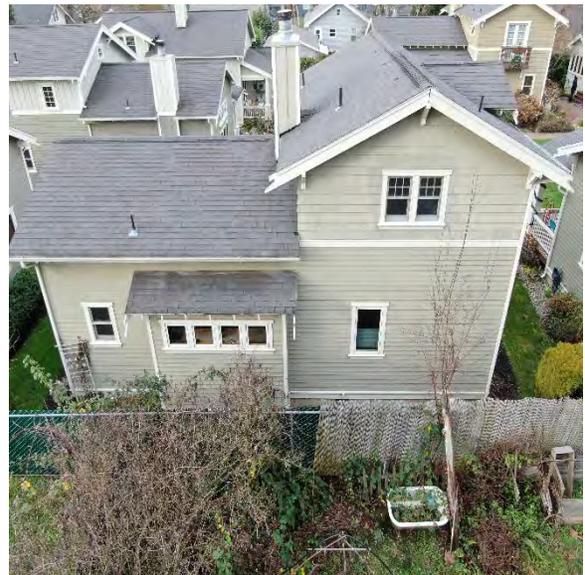
Typical rear elevation

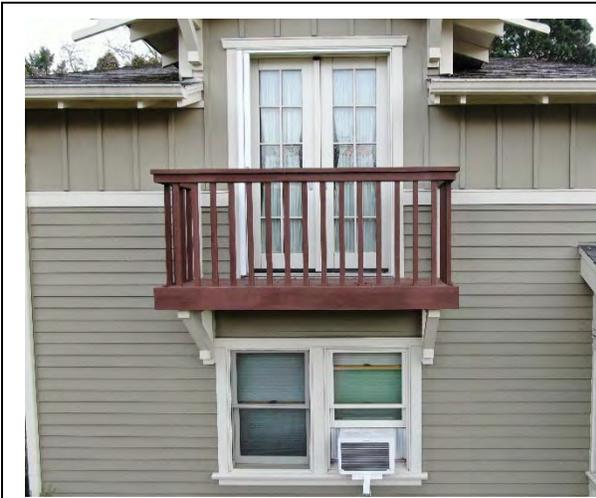
Typical deck

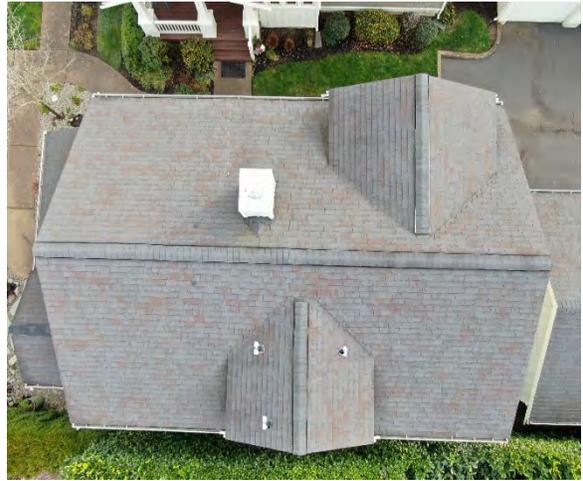
Typical roof

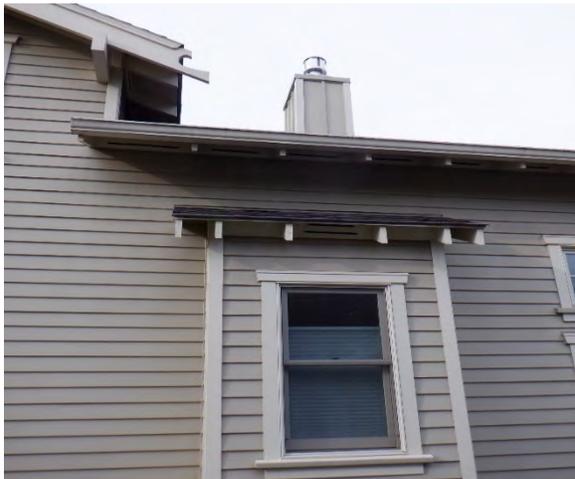
Typical eave venting

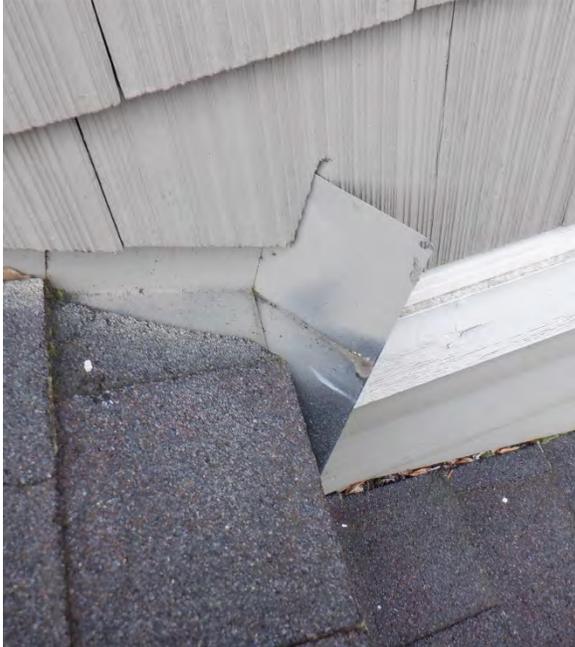
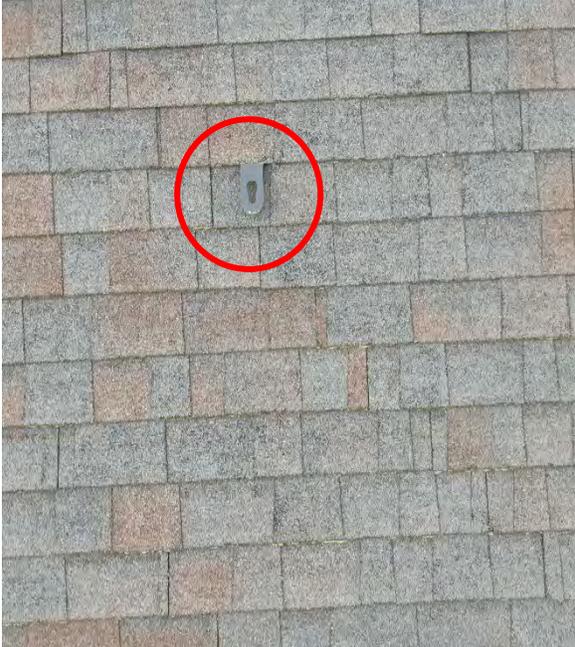
<p>1.1 Typical kickout diverter flashing</p>	<p>1.2 Typical safety tie off anchor</p>

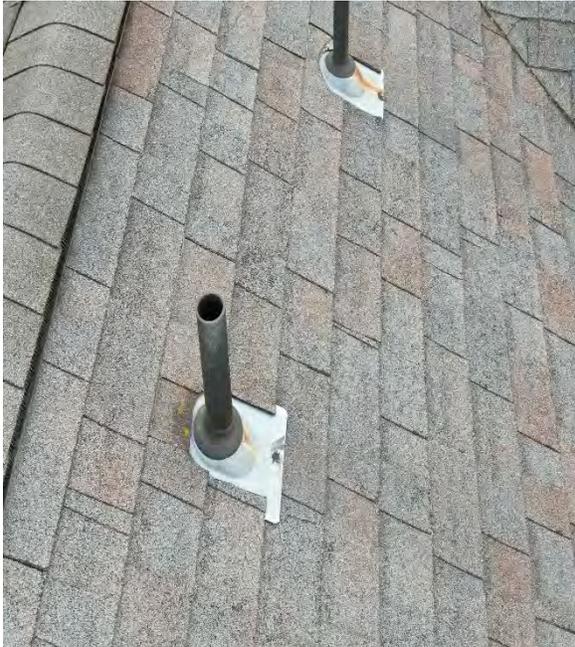
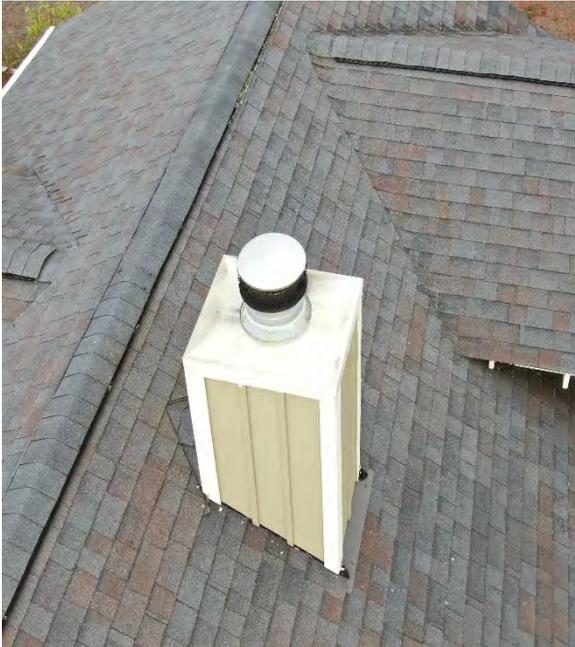
<p>1.3 Typical dormer</p>	<p>1.4 Typical chimney chase</p>

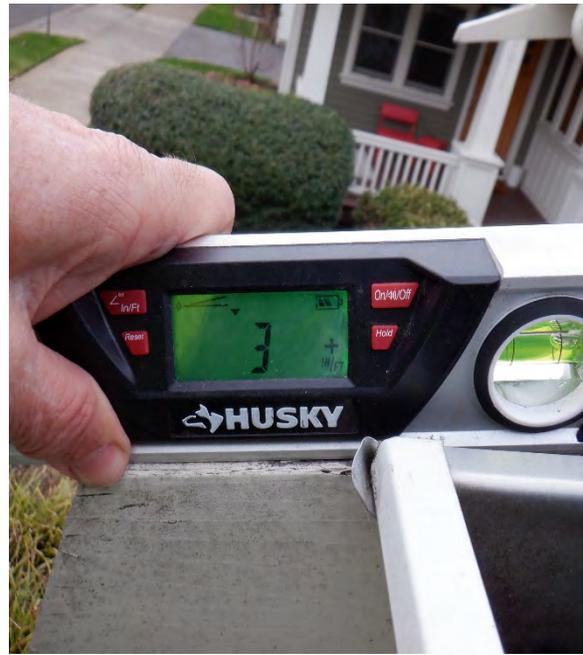
1.10 Typical roof pitch is 3/12 and self-adhered membrane was installed as the underlayment.

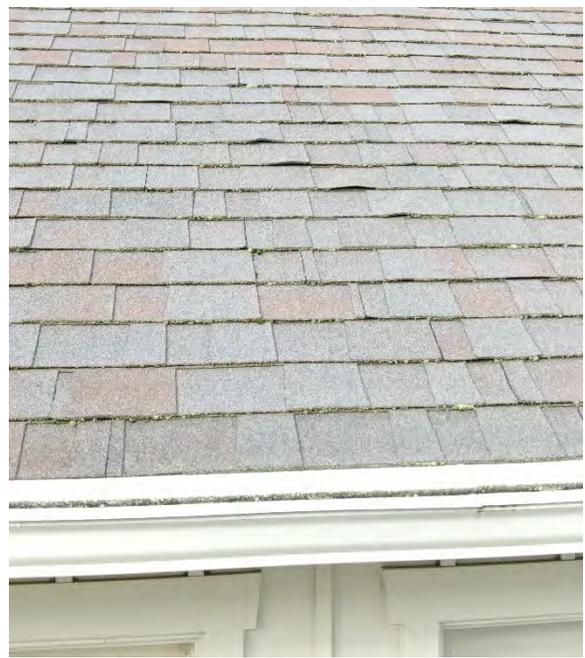
1.13B Closer view of shingles butted tight to each other.

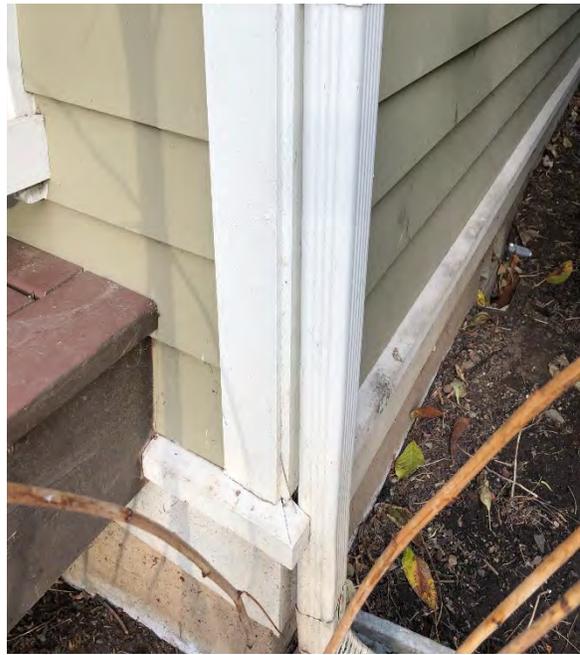
3.5B Another example of omitted flashing at lower trim.

**Walls:** Hire qualified contractor to address minor repair/maintenance items noted in Observations section. Walls and associated components should be reviewed on a regular schedule to ensure any needed repairs/maintenance are addressed as they become evident.

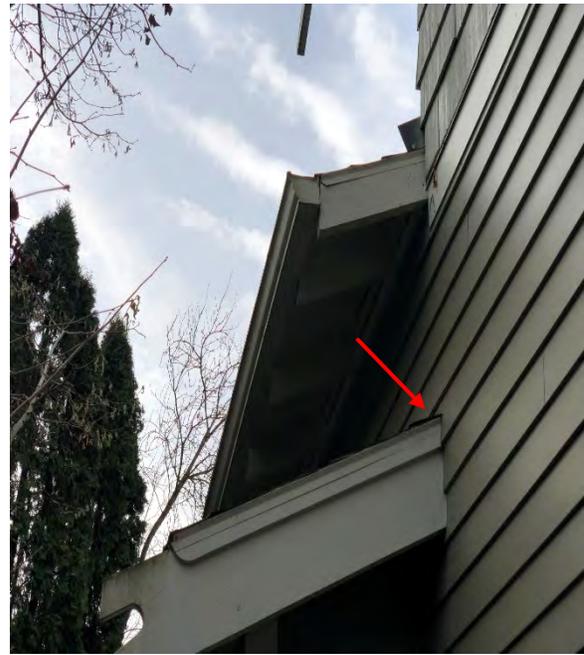
3.7B Another example of sealant dependent flashing at rake edge/siding.

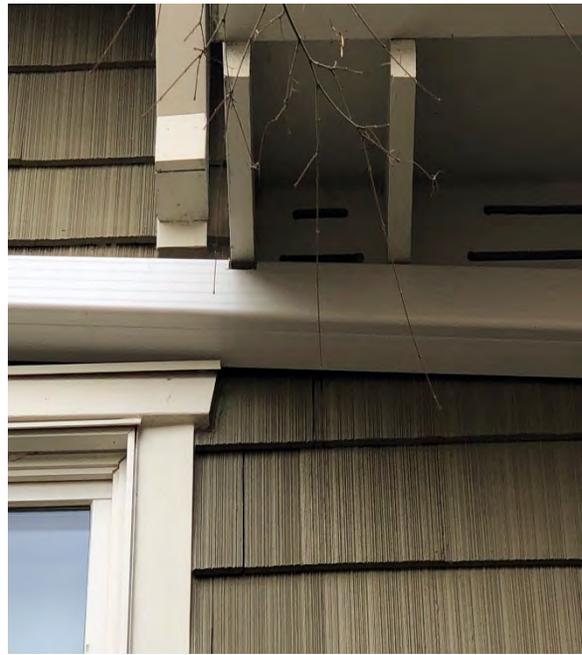
3.9B The protective line cover is cut, which could allow water to be trapped in the cover.

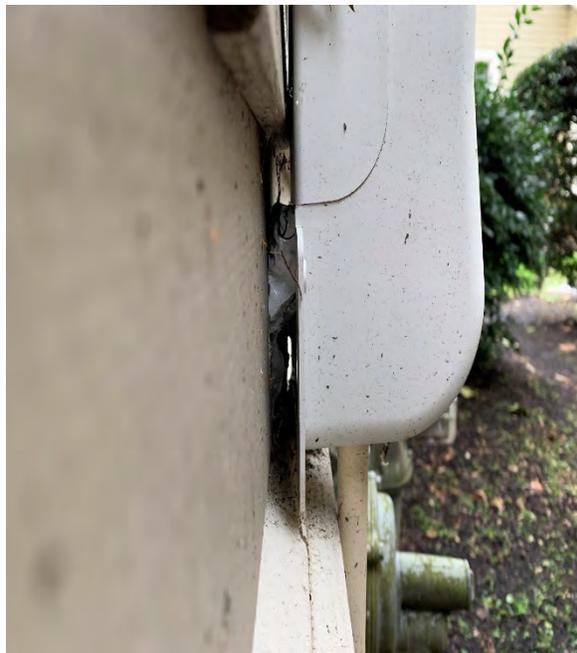
3.9C Closer view of line set penetrating siding behind the line hide cover.

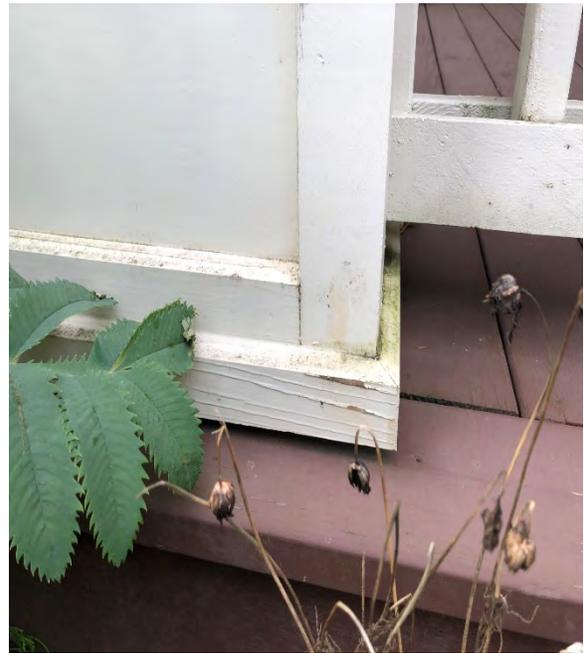
**Decks:** The decks are generally in good condition, except for the kick board at the first step and the columns. At most buildings, the kick board is deteriorating due to being in contact with the ground. Column corner joints are beginning to separate and show signs of decay as well.

5.2B Another example of peeling paint at column trim.

**Decks:** Clean on a regular schedule to help ensure full useful life of deck boards. Hire qualified contractor to replace any decayed kick boards. Ensure a clearance is maintained between bottom of kick board and ground so that these boards do not decay as well. Seal corners of columns that are separating and replace any that are decayed.
