COTTAGES AT HASTINGS GREEN

ROOF ASSESSMENT

PONO BUILDING CONSULTANTS

August 11, 2023

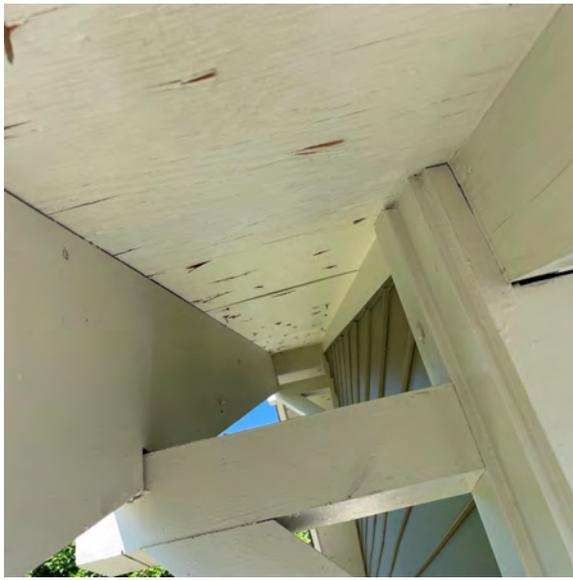
1C. Additional example of fasteners penetrating sheathing at eave.

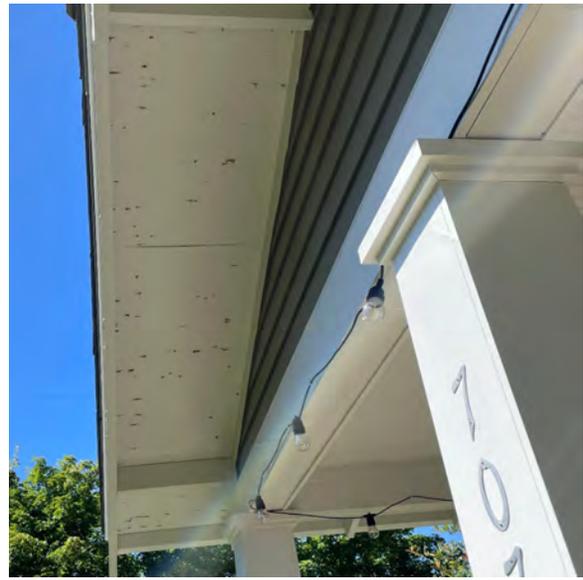
1D. Additional example of fasteners penetrating sheathing at eave.

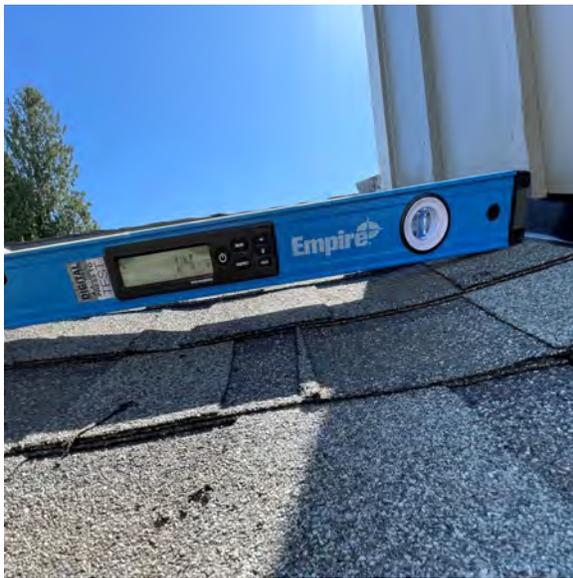
2. Low point present in roof sheathing.
Location: 7055

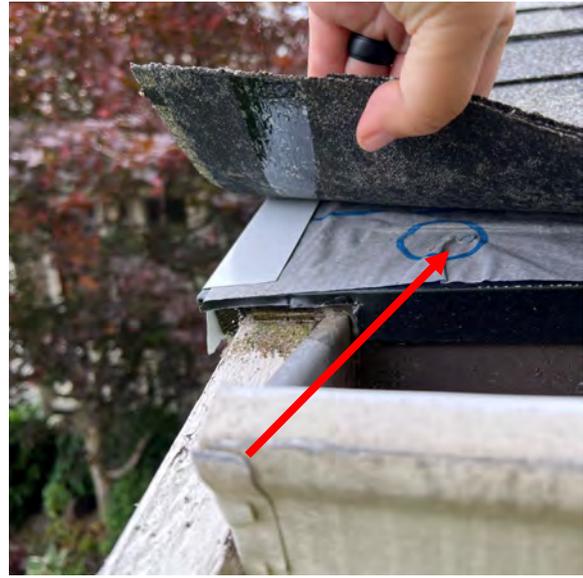
6B. Additional example of flashing fastener penetrating underlayment.

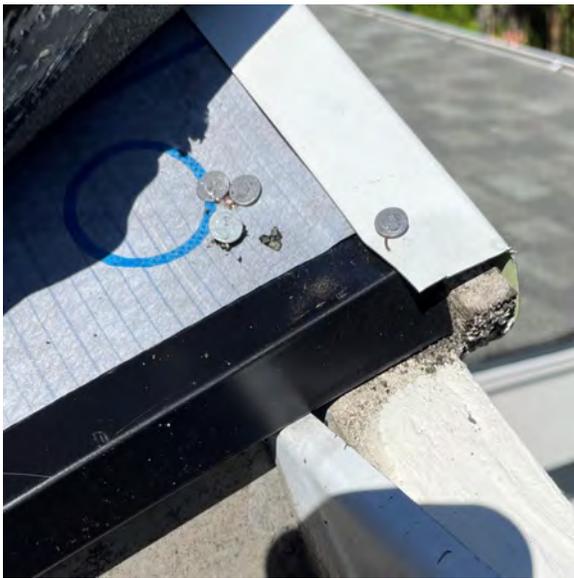
6C. Additional example of flashing fastener penetrating underlayment.

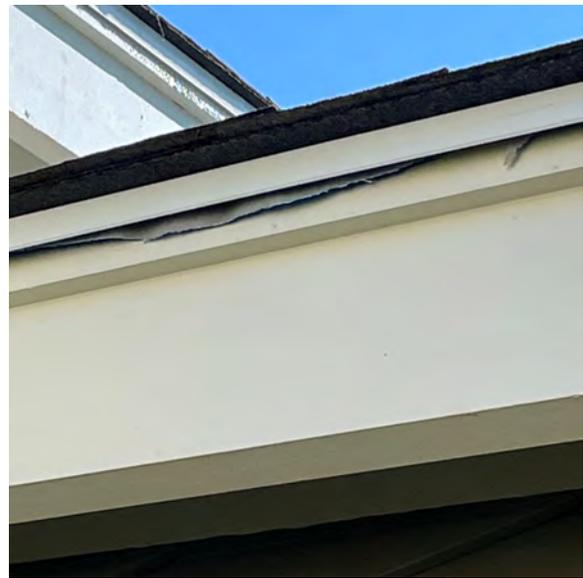
10. Excess underlayment is exposed at the rake edge flashing.

Location: 7063

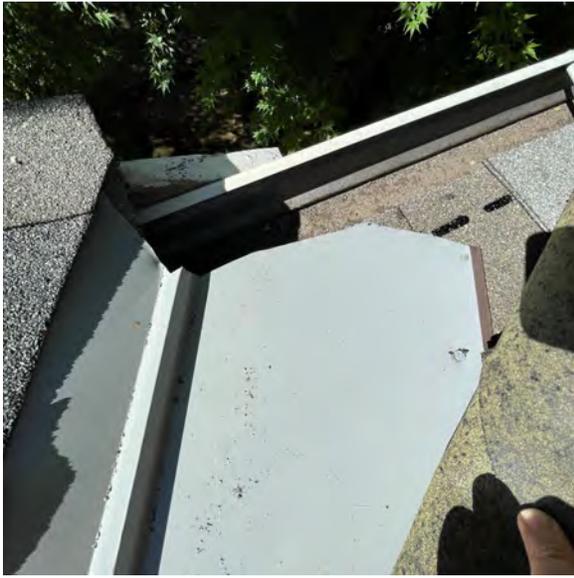
11. Metal valley installed and properly secured at edges. Valley extends 12" from center.

Location: Systemic throughout property

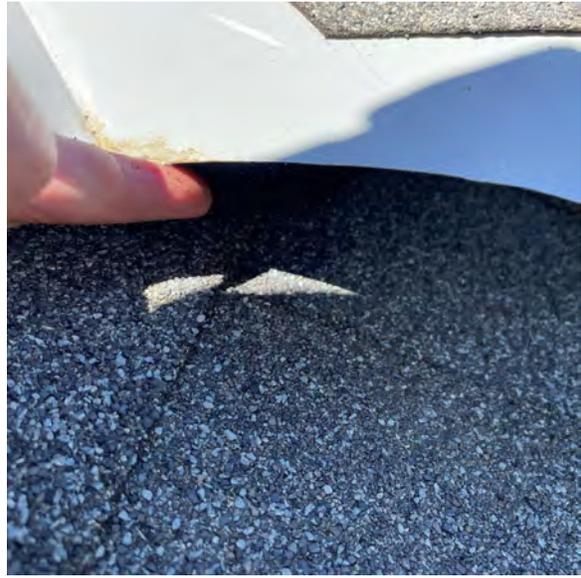
12. Metal valley does not sit flush against roof.

Location: 7029

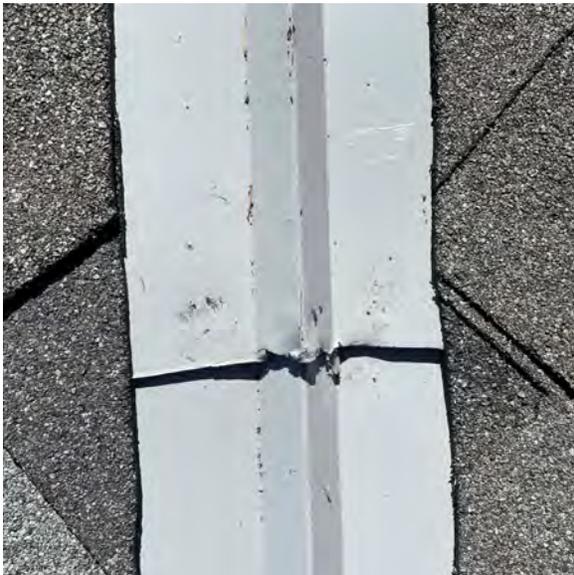
13. Metal valley end lap edge is jagged.

Location: 7029

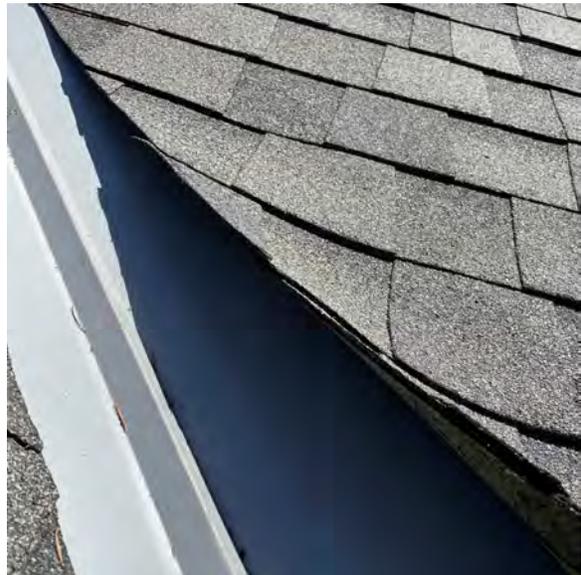
14. Shingles near metal valley are not properly fastened or sealed. Also note, the starter strip is not installed to roof edge.

Location: 7029

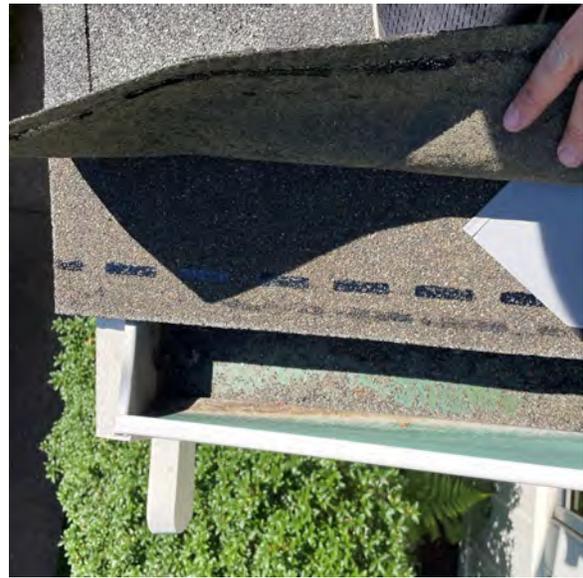
16. Starter strip fasteners omitted.
Location: 7021, 7071

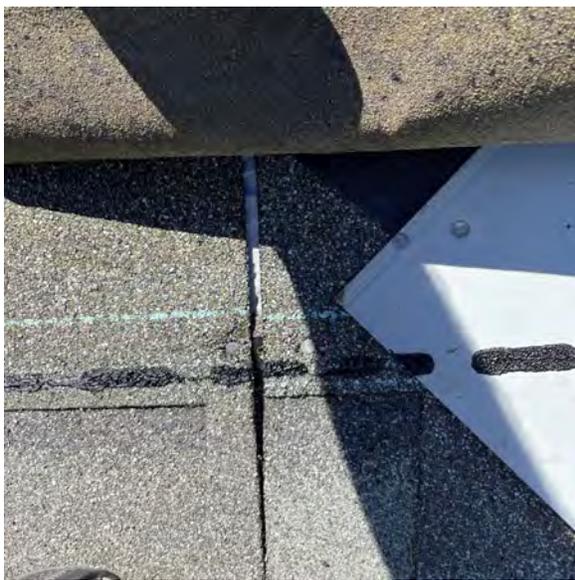
17. Gap present between shingles.
Location: 7029

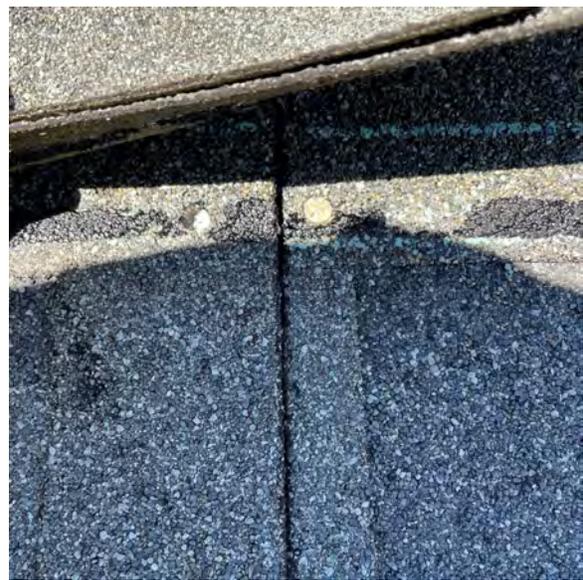
18. Shingle fastener installed too close to shingle butt joint. The manufacturer requires fasteners to be installed 1" from butt joint.
Location: 7033

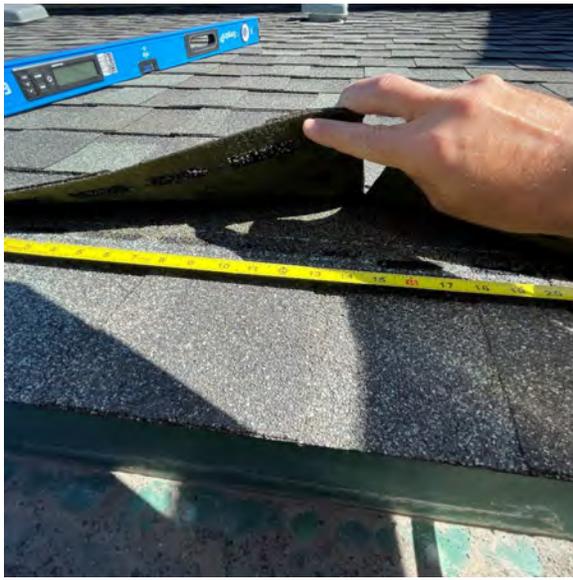
19. Only two fasteners are present in the shingle course nailing line. Manufacturer requires six nails per shingle course.
Location: 7076

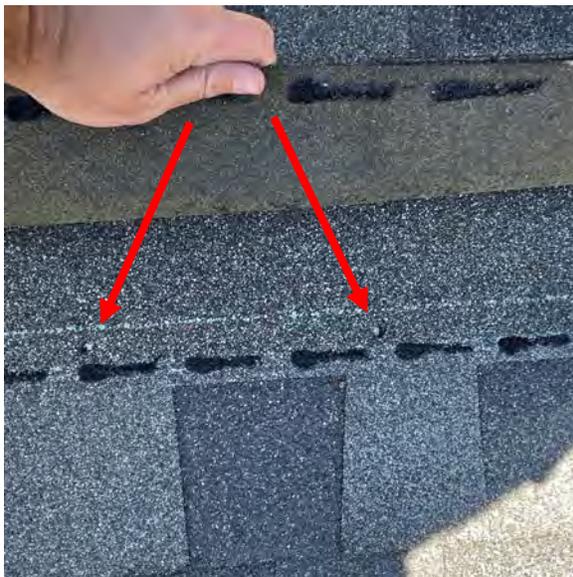
20B. Additional example of overdriven nails.

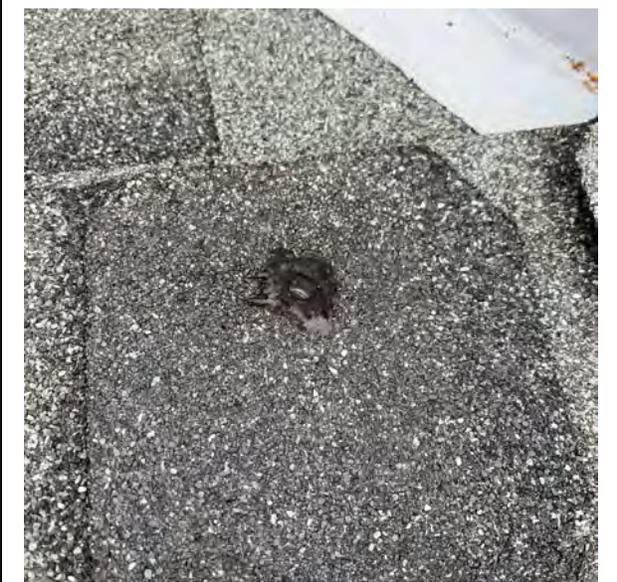
23A. Exposed fastener at ridge shingle is not properly sealed.
Location: 7042, G20-23

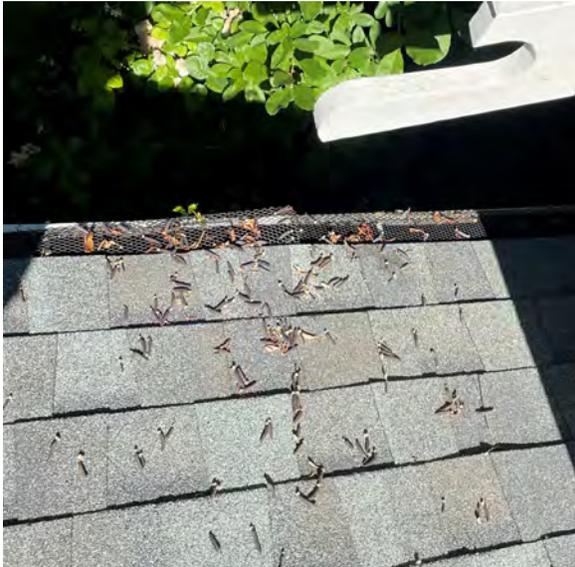
<p>29. Debris present on shingles. Roof should be cleaned on a regular schedule to prevent debris build-up. Location: 7059</p>	<p>30A. Clearance between shingles and siding is less than 2". A minimum 2" clearance should be maintained between these dissimilar materials. Location: 7021, 7025, 7029, 7039, 7059, 7063, 7071, 7076</p>

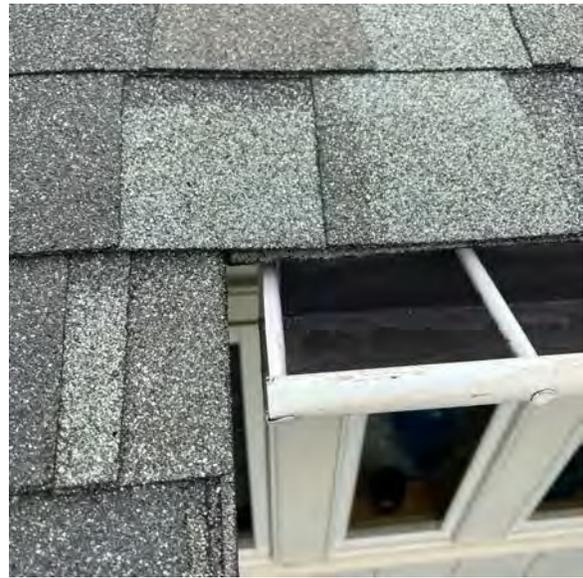
36A. Diverter flashing at drip and rake edge omitted.
Location: 7022, 7046, 7067, G1-5, G20-23

Remove step flashing and diverter flashing. Install new properly sized, properly integrated step flashing and diverter flashing.	G1-5	Yes
Install properly dimensioned diverter flashing where omitted at drip and rake edges.	7022, 7046, 7067, G1-5, G20-23	Yes
Remove inadequately sized diverter flashing. Install new properly dimensioned diverter flashing, ensuring proper integration with existing assemblies.	7021, 7025, 7029, 7033, 7046, 7059, 7076	Yes

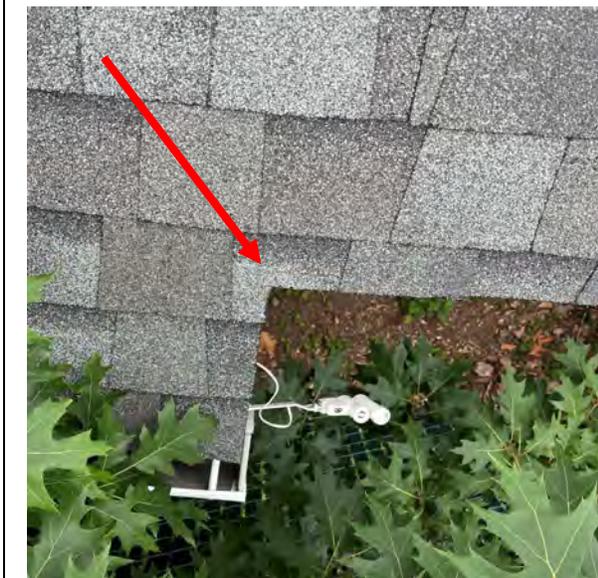
36B. Additional example of omitted diverter flashing.

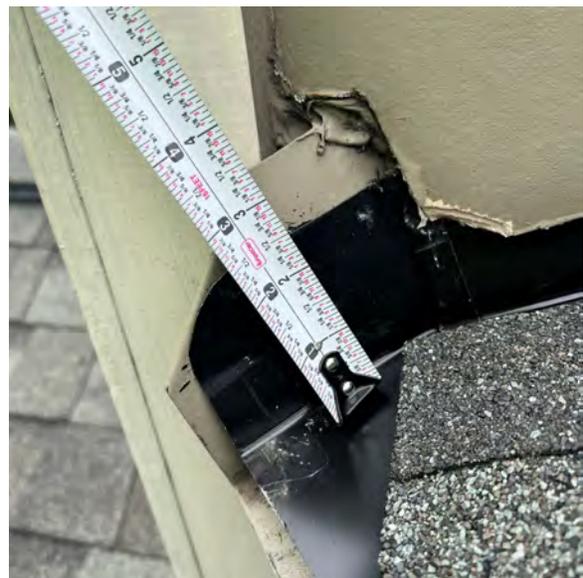
37A. Diverter flashing is undersized, measuring 2.5" in height.
Location: 7021, 7025, 7029, 7033, 7046, 7059, 7076

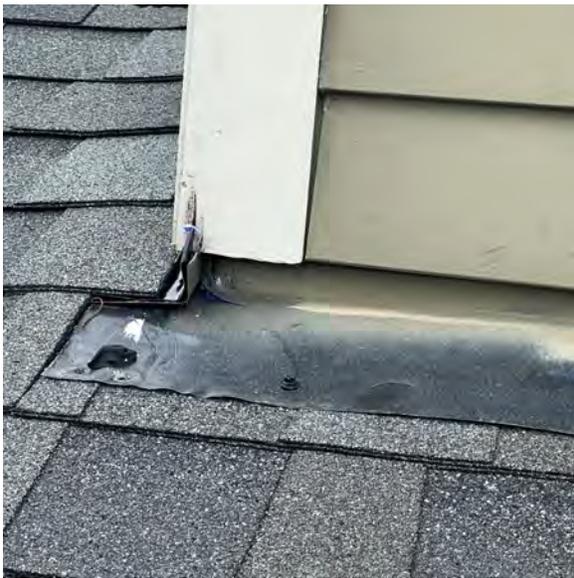
39. Sealant omitted at diverter flashing and corner trim joint.
Location: 7042

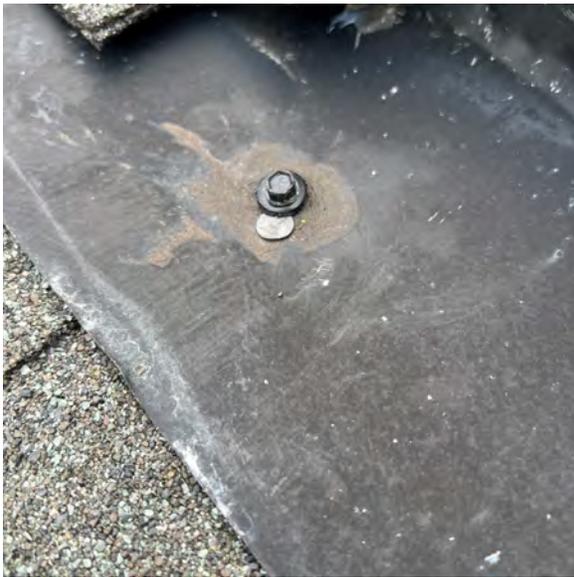
42. Exposed fastener at apron flashing is not sealed.
Location: 7026, 7034, 7039

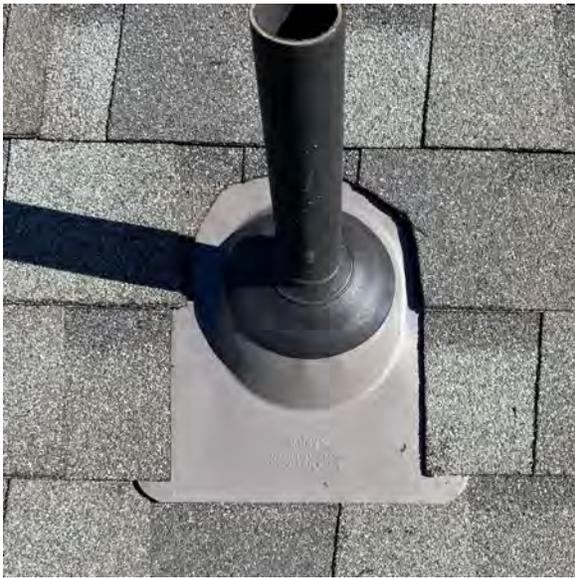
<p>47. Penetration flashing installed without proper grommets fasteners. Location: 7029 & 7063</p>	<p>48. Exposed fastener at new safety anchor is not sealed. Location: Systemic throughout property</p>

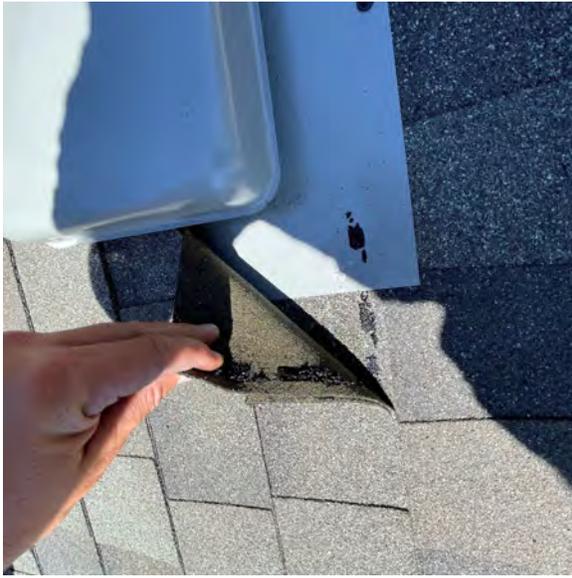
51. Ice and water shield omitted at RVO vent.
Location: 7025, 7029, 7033, 7039

Install ice and water shield at RVO vent.	7025, 7029, 7033, 7039	Yes
Seal open seam at chimney back pan.	7051	Unable to determine
Remove failed sealant at chimney cap. Apply new sealant.	7071	Unable to determine
Install grommets fastener where missing at chimney cap.	7071	Unable to determine
Reset barge board so that rake edge flashing is properly seated.	G6-10	Yes

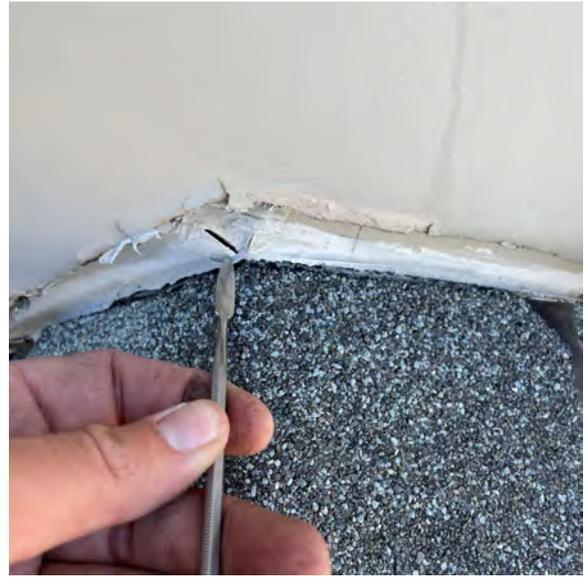
52. Unsealed seam present at chimney back pan.
Location: 7051

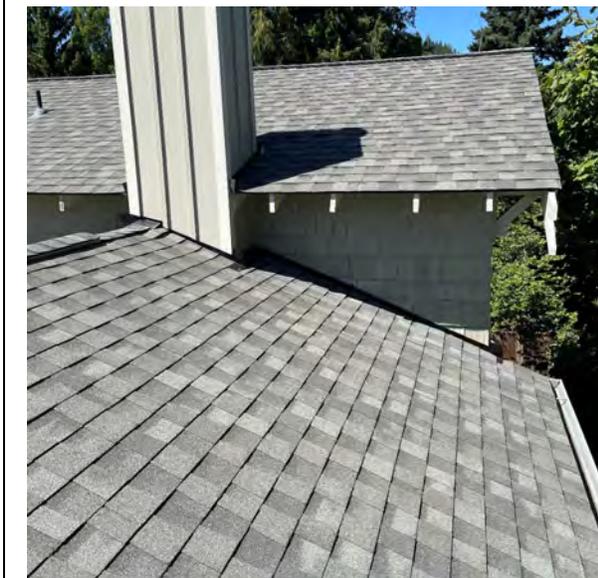
61B. Additional example of omitted gutter at dormer drip edge.

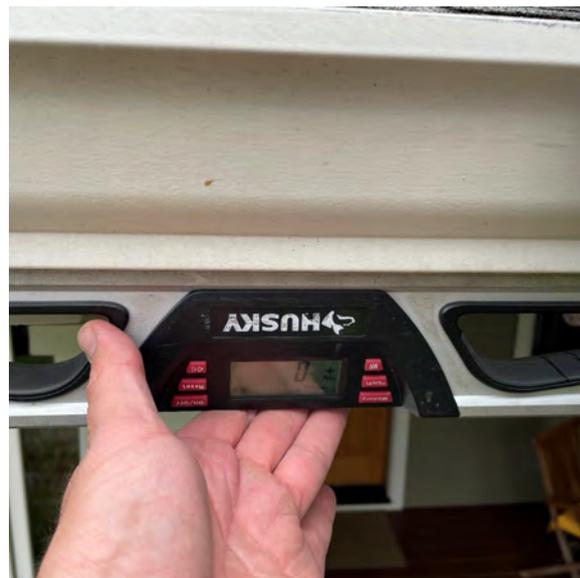
62. Gutter installed with zero slope towards the downspout, preventing proper drainage.

Location: 7067, 7071

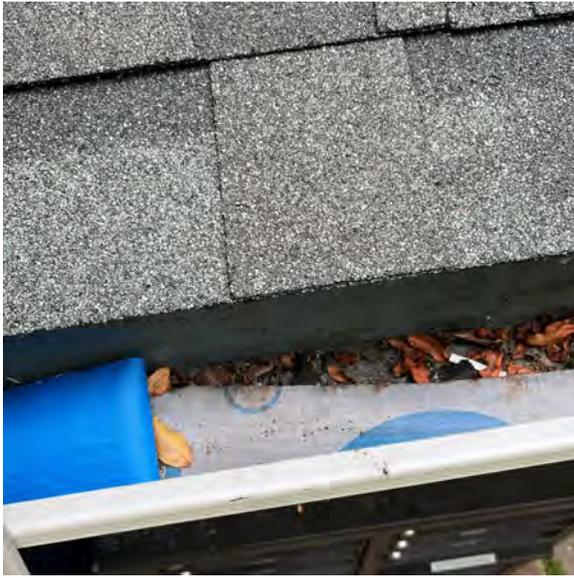
63. Debris present in gutter. Gutter should be cleaned on a regular schedule to ensure proper drainage.
Location: G6-10

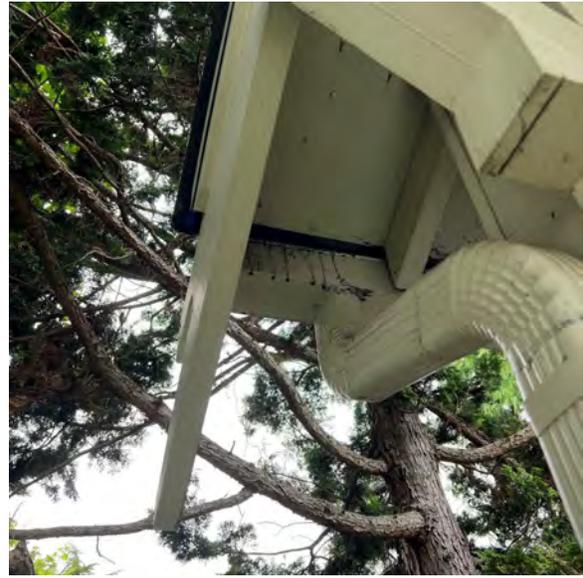
64. Evidence of gutter overflow present.
Location: G12-14

Recommended Repair	Location	Carlson Scope
Remove decayed/damaged barge board. Replace with new. Paint to match existing. Ensure end cuts are primed.	7030, 7039, 7071, G6-10	Yes (allowance item)
Remove decayed/damaged rafter tail. Replace with new. Paint to match existing. Ensure end cuts are primed.	7026, 7055	Yes (allowance item)
Remove gutter. Reinstall so a minimum 1" gap is maintained between gutter end cap and barge board.	Global	Yes
Extend drip edge metal flashing into gutter so that no gap is present between gutter and drip edge. Properly secure gutters so they are not pulling away from the drip edge.	Global	Yes
Install gutters at upper dormer drip edges.	Global	No
Remove gutters. Reinstall with slope of 1 unit per 48 units.	7067, 7071	Yes
Remove roofing debris from gutter.	G6-10	Yes
Clean gutters on a regular schedule to prevent overflowing.	G12-14	No
Properly connect gutter to downspout.	7071	Yes

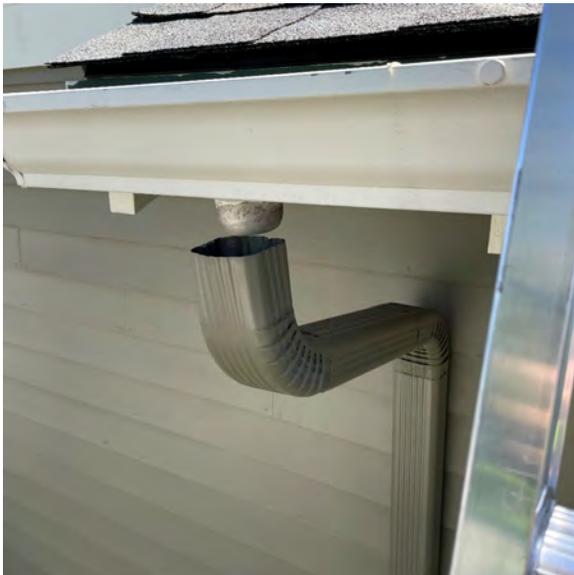
65. Gutter is not connected to downspout.
Location: Unit 7071

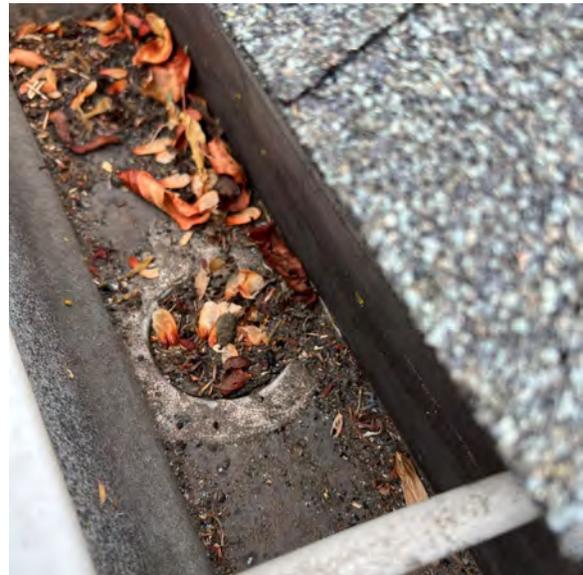
66. Downspout is clogged with debris. Downspouts should be cleaned on a regular schedule to prevent debris build-up.
Location: G6-10

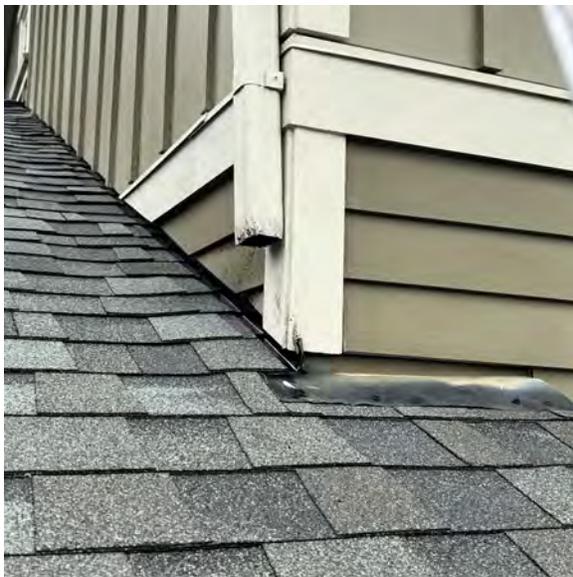
67C. Additional example of downspout draining directly onto lower roof.
